Habitat assessment and ecological restoration design for an unnamed tributary of Stone Dam Creek, Conway, Arkansas

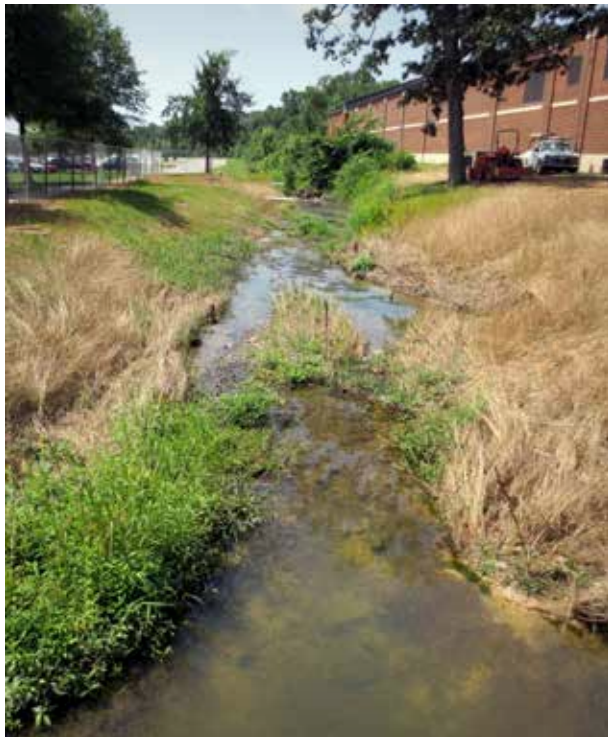
Study Area. The unnamed tributary leads into Stone Dam Creek on the UCA campus in Conway, Ark. It is part of the 109.04 km² Little Creek–Palarm Creek watershed, which is 35.5% urban cover and home to three major universities (ANRC, 2006). The tributary is highly channelized, and runs underground until it surfaces between a large parking lot and the UCA's Health, Physical Education, and Recreation (HPER) building (Fig. 1),

Fig. 1. Downstream view of the unnamed tributary of Stone Dam Creek on the University of Central Arkansas campus, Conway, Ark. University of Central Arkansas Health, Physical Education, and Recreation building shown on the right, with a large parking lot to the left.

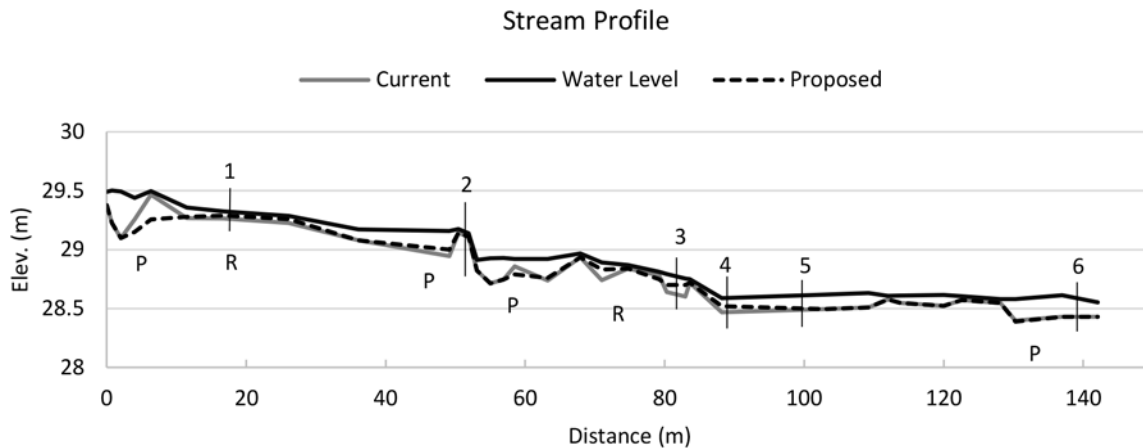
Overall average habitat assessment score equaled 71.2 out of a possible 200. Average scores by parameter and a description of the category class that each score falls under are provided in Table 2. Figure 4 shows the stream profile, measured at the thalweg, as well as the measured water level. The profile shows the measured morphology of the tributary, indicating where riffles and runs are currently located along the study area. Figure 4 also shows the proposed restoration plan's profile.

The poor scores for epifaunal substrate/available cover and frequency of riffles (Table 2) indicate that habitat diversity is lacking in the stream system, which reduces the number of niches available to insects, fish, and macroin-

Fig. 4. Current and proposed stream profiles and measured water level of an unnamed tributary of Stone Dam Creek, Conway, Ark. Surveyed cross sections are labeled as 1-6. Areas of pools (P) and riffles (R) are labeled along the profile.

vertebrates (Barbour et al., 1999). The proposed profile improves existing geomorphology in the stream with the purpose of restoring a more natural channel structure. The main limiting factor in this design is the dam structure and the position of bedrock within the channel. The new profile elongates and deepens existing pools and increases the frequency of riffles from >25:1 to 4.5:1 ratio of distance between riffles divided by width of the stream. A change in riffle frequency would raise the RBP score for that parameter from poor to optimal. Creation of more diverse morphology, including deep pool areas, also increases the velocity/depth regimes present from two to three, which would increase the parameter score from marginal to suboptimal/optimal.

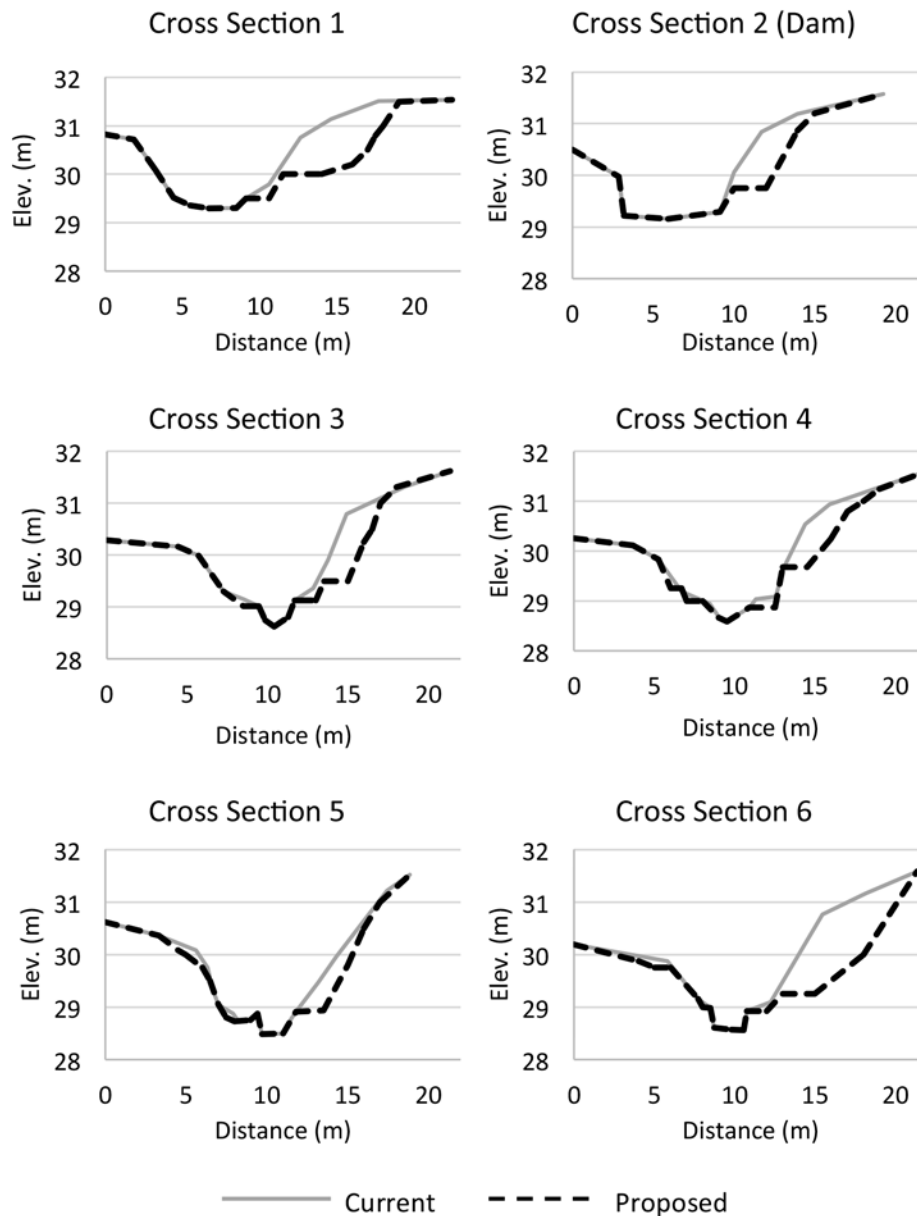
Low habitat assessment scores for bank stability indicate a possible erosion hazard. Using the rational method

Fig. 5. Cross-sectional view of the six cross sections, measured and proposed, at an unnamed tributary of Stone Dam Creek, Conway, Ark. See Fig. 2 for location of cross sections.

(Eq. 1), peak flow (Q) was calculated to be $1.33 \text{ m}^3/\text{s}$. To address the risk of erosion, cross sections were designed to increase area, which would reduce stream velocity and reduce the erosion hazard. The bedrock that was predominant along the streambed, as well as the presence of the HPER building and the sidewalk bordering the parking lot restricted the amount of alteration possible for the cross sections; however, cross-sectional area was increased on all 6 transects by creating a step cross-sectional profile (Fig. 5). This allows a higher channel during high flow conditions. Velocities for the cross sections 1-6 were reduced by 18.6%, 11.9%, 10%, 13.9%, 36%, and 27%, respectively, with the proposed designs. The reduction in erosion would also reduce the amount of fine sediment and reduce embeddedness, which would further increase the habitat assessment score.
