Multiaxial Fatigue of Notched Steel Plates and Investigation of CFRP Retrofits for Crack Initiation Prevention

An Undergraduate Honors College Thesis

Department of Civil Engineering
College of Engineering
University of Arkansas
Fayetteville, AR

May 2020

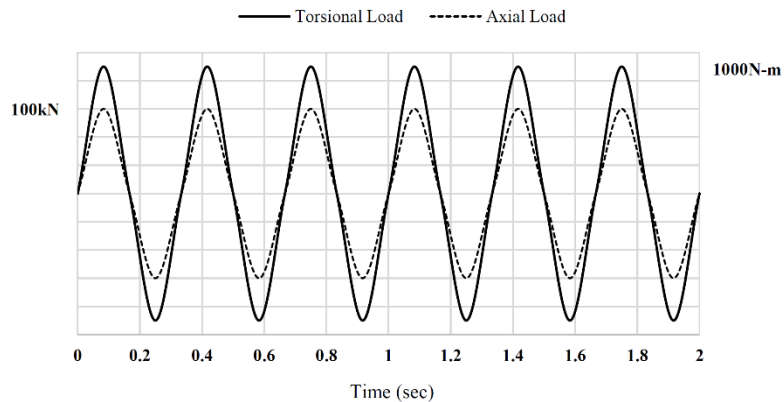
Figure 1. Load-Time Curve of In-phase Loading at 3Hz.

initiation. The research was divided into two parts, and each part consisted of three tests; 100 kN (22.5 kips) axial tension test, 1000 N-m (738 lb-ft) torsional test, and combined in-phase axial tensile-torsional loadings test. For the in-phase axial-torsional test, the maximum value of the axial stress waveform occurs simultaneously with the maximum value of the shear stress waveform [2]. Figure 1 shows the load time-history for the combined in-phase loading. Each of the three tests were run three times for a statistical purpose. The majority of tests were performed at a loading frequency of 3Hz; however, there were small variations in loading frequency between tests to accommodate the different phases of loading and machine performance requirements.

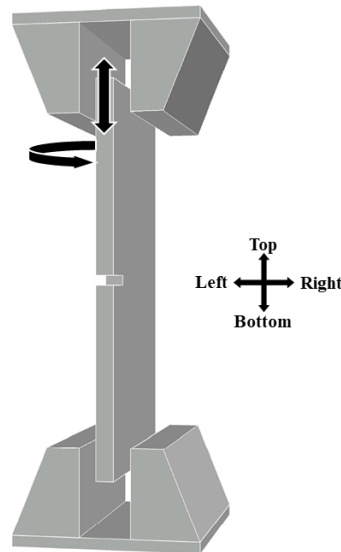
Figure 2. Schematic of experimental testing setup

Figure 2 shows the simple representation of the experimental setup. Any notations regarding the plates (top, bottom, right, left, etc.) will be based on this figure throughout this thesis.

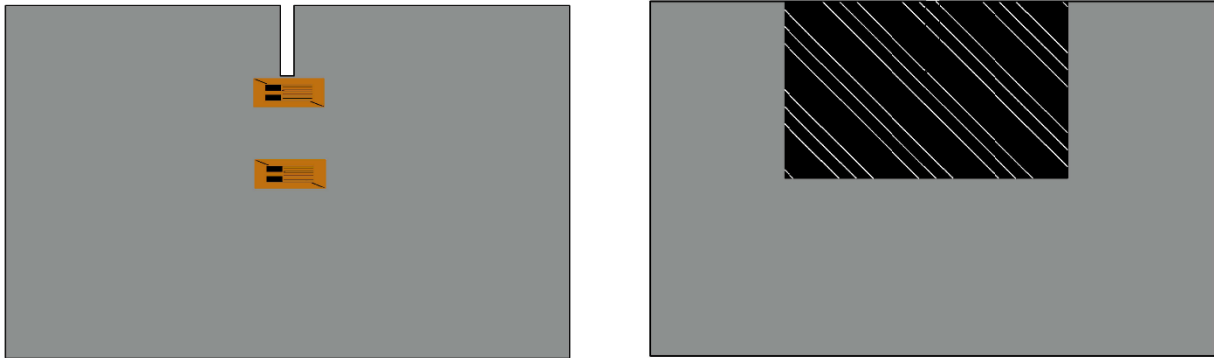
Figure 3. (a) Specimen with Strain Gauges (b) Specimen with CFRP Retrofit

In order to know the nominal stress and strain, and the concentrated stress and strain at the crack edge, strain gauges were used on one of the plates for each loading combination. The strain gauges were located on at the center of the plates and at the edge of the notch of both sides

of the plates (see Figure 3(a) below). Strain data of a total of six plates were recorded at 0.01 seconds intervals for the first 10 seconds of every hour to capture any changes due to crack growth.

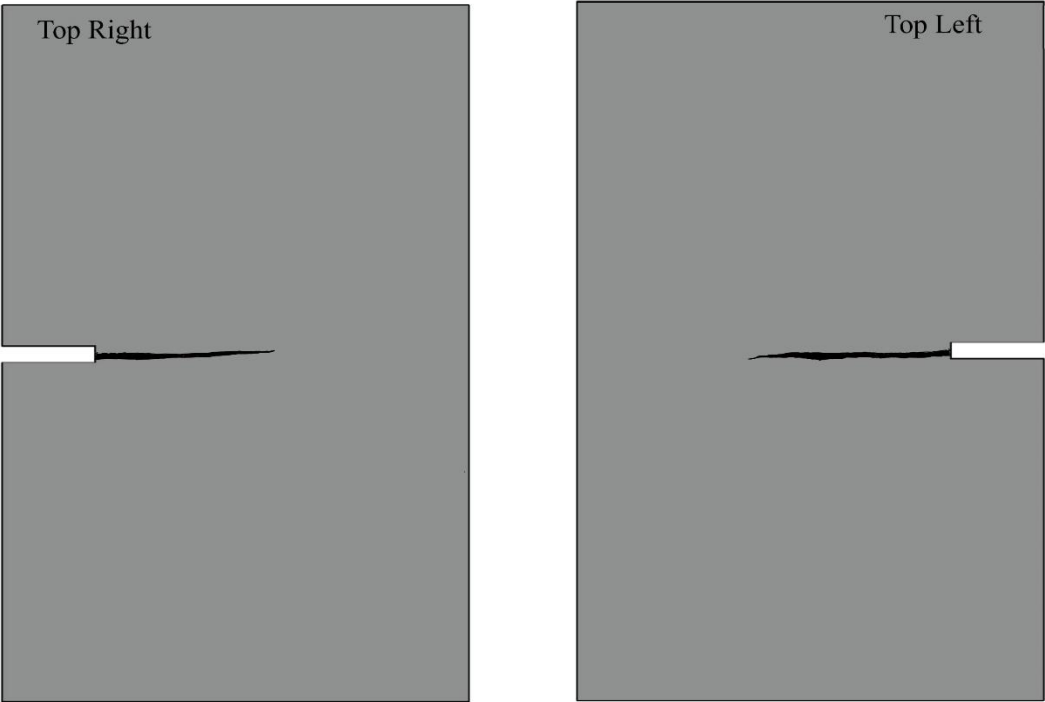
Figure 4 below shows the crack geometry when the plate failed. As shown in Figure 4, the crack developed horizontally from the notch such that it split all the strain gauges and it penetrated the plate. It is considered that the crack abruptly developed around the point at which the plate reached a stroke of 1mm.

Figure 4. Crack Geometries of Plates after Axial Loading Test

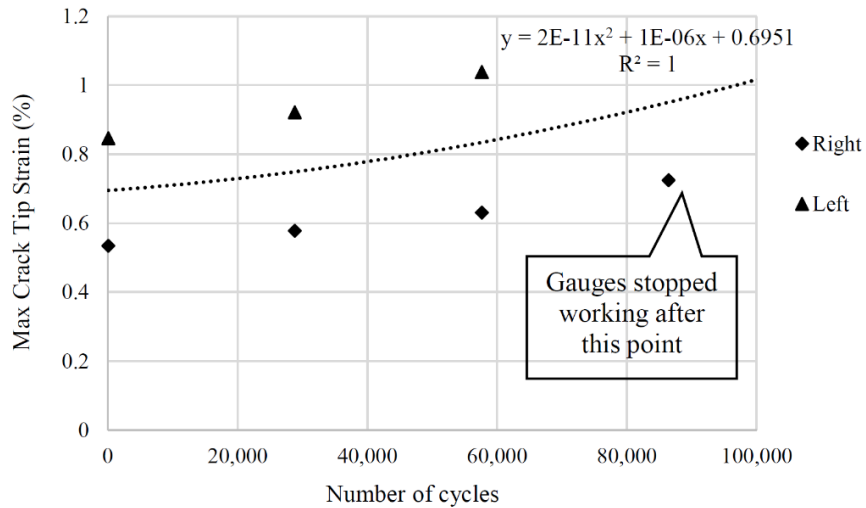
In order to show the rate of the change in strain, a graph of strain to number of cycles was plotted. Figure 5 below shows the maximum strain at the crack edge on both sides of the plate at several points in time during the test.

Figure 5. Change in Strain Over Time under Axial Loading

Recorded strain gauge data was not obtained after 86,450 cycles due to either the crack growing through the strain gauge or the gauge becoming unbonded. Also shown in the graph is the trendline of the average values of right and left strain to number of cycles. Even though only a few data points are shown, we can see that there is nearly a quadratic relationship between strain and duration at which load was applied.

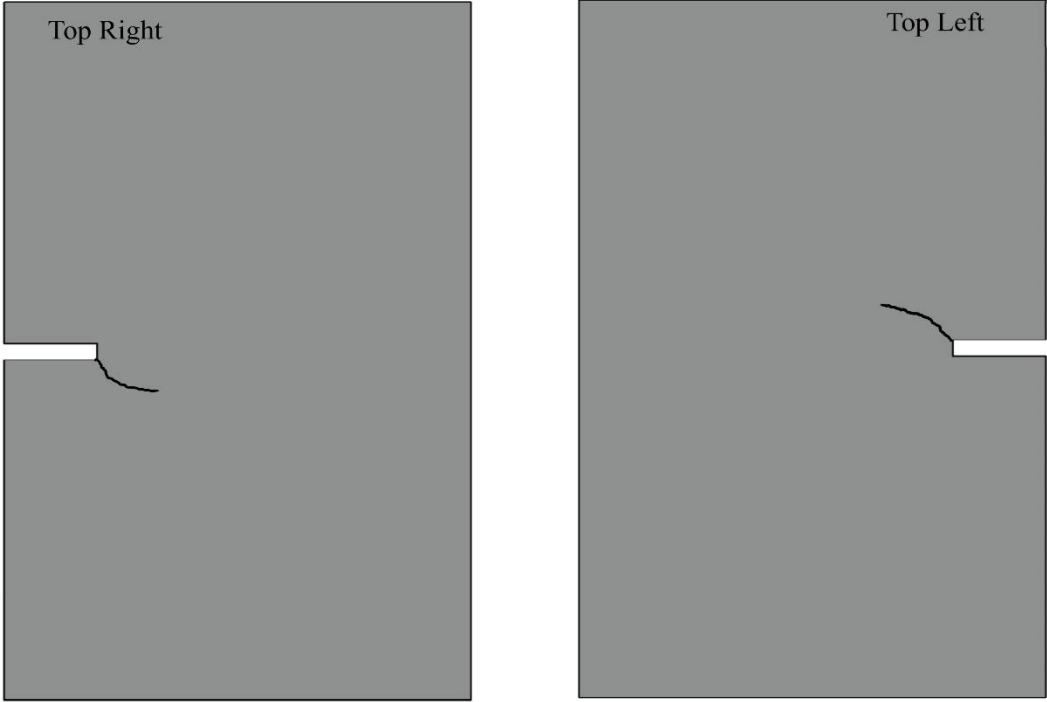
Figure 6 below shows the crack geometry when the plate failed. The cracks developed in different directions on the right and left side. The cracks did not penetrate the plate, rather, they occurred only on the surface from the visual observation. In addition, due to the twisting motion, there was a small deformation in the left-right direction.

Figure 6. Crack Geometries of Plates after Combined Loading Test

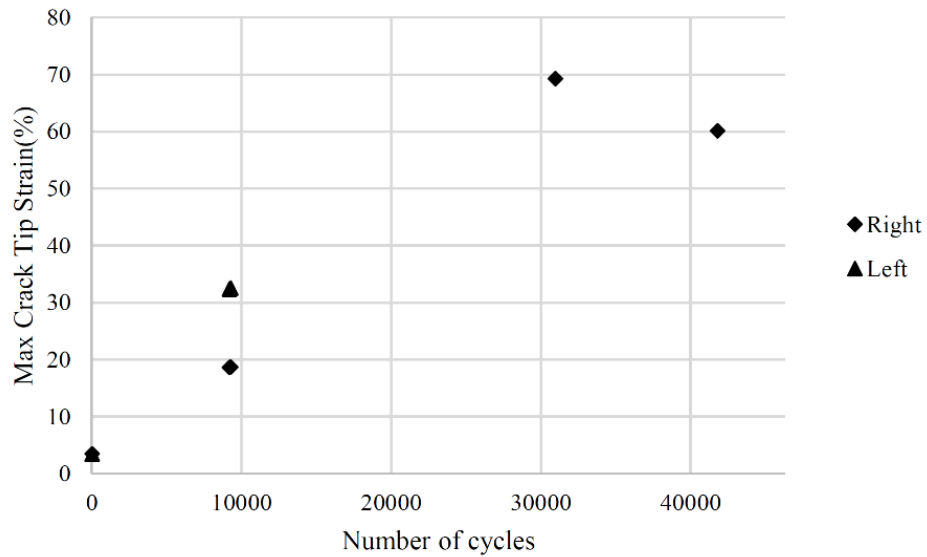
Shown in the graph below is the relationship between strain and number of cycles stress was applied (Figure 7). Some of the data are missing due to troubles with electrical connectivity between gauges and the recording machine; however, it can be observed that the measured plate strain and number of cycles remain proportional, with increases in strain be connected to increases in the number of loading cycles as the crack grows.

Figure 7. Change in Strain Over Time Under Combined Axial-Torsional Loading

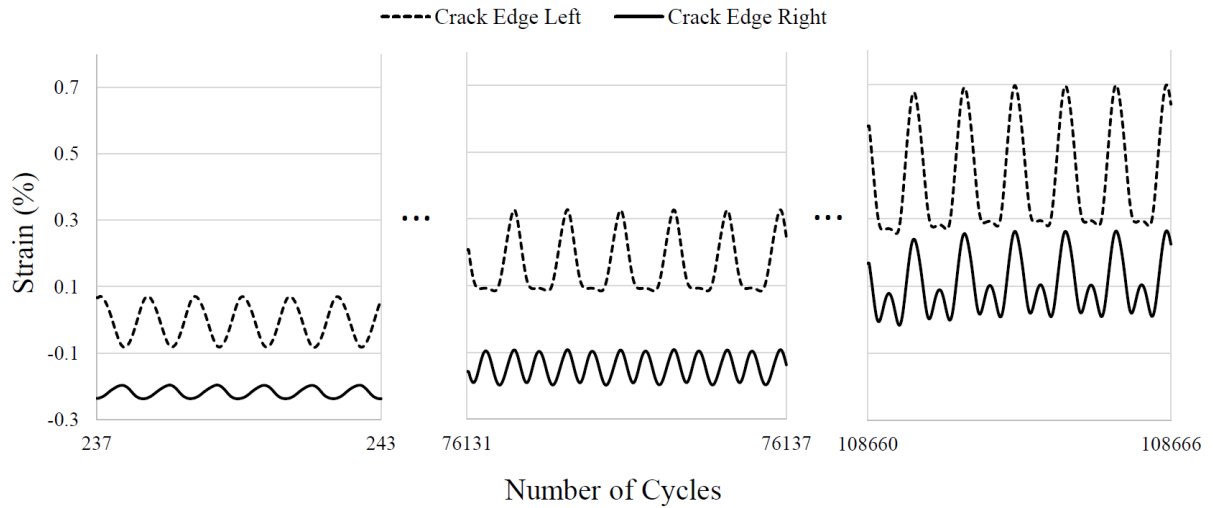
Torsional only stress test on plates without CFRP retrofit was run two times, one with strain gauges and one without strain gauges. The number of cycles at which each specimen failed was 115,970 and 202,148 respectively. In a torsion test, the single strain gauge at the crack edge does not tell us the true concentrated stress. The transition of strain-number of cycles curve with the passage of time is shown in Figure 8. It can be seen from the graph that in the early phase of the test, the series of the strain of the right side and the left side of the plate are out of phase. However, in the middle of the test, the strain of the right side goes through two cycles while the

strain of the left side goes through one cycle, and in the final stage of the experiment before the failure, the waveform of strain of the right side and the left side are in phase.

Figure 8. Strain Waveform Over Time under Torsion Loading

This irregularity is attributable to the fact that under shear stress, a strain gauge measures strain of compressive or tensile stress generated from the shear stress, rather than the strain due to the shear stress itself [3]. Therefore, it is difficult to accurately estimate at what cycles the plate yielded. In order to obtain more accurate and detailed strain and stress data, several methods could have been utilized. One of the ways is to perform finite element analysis (FEA). Although it will be only a simulation of load effects and still needs to be verified experimentally, it allows us to predict the stress states of the analyzed section in detail. Another way is to use more strain gauges. By combining strain data of multiple (usually three) gauges that are arranged so that two of them are oriented at $+45^\circ$ and -45° to the loading axis and the other one is oriented at 90° to the loading axis [4], it is possible to measure the true shear strain which takes twisting motion into account.

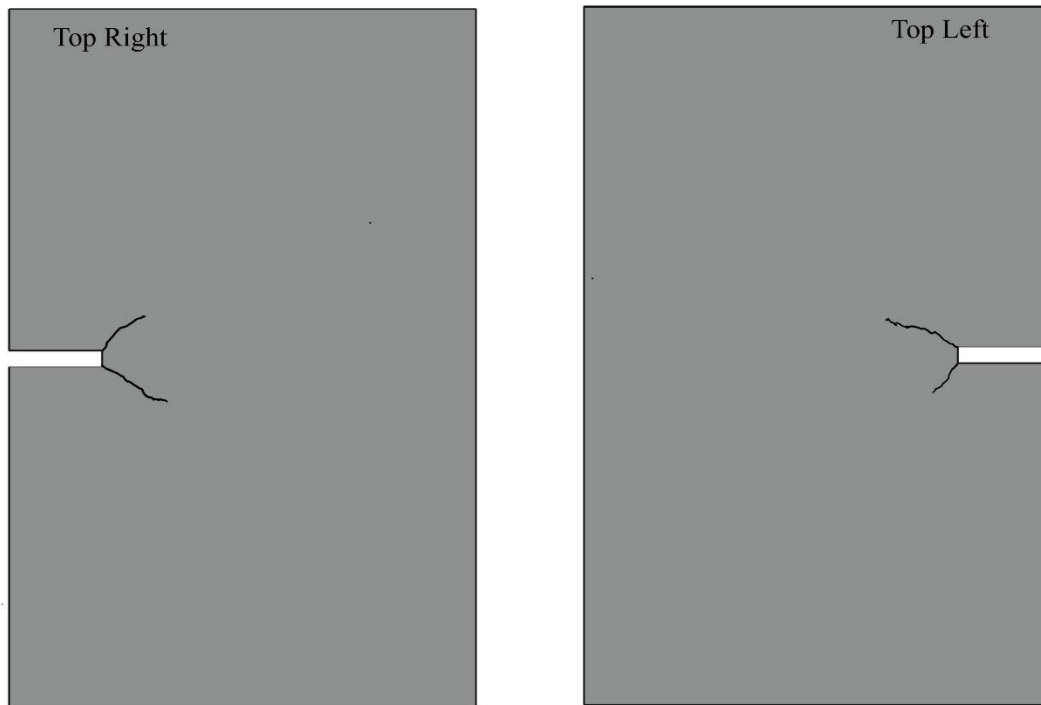
In Figure 9, the crack geometry when the plate failed is exhibited. The cracks developed in two different directions from the edge of the notch. Just like in the combined test, the cracks occurred only on the surface and did not penetrate the plate. In addition, due to the pure twisting motion, there was a larger deformation in the left-right direction.

Figure 9. Crack Geometries of Plates after Torsional Loading Test

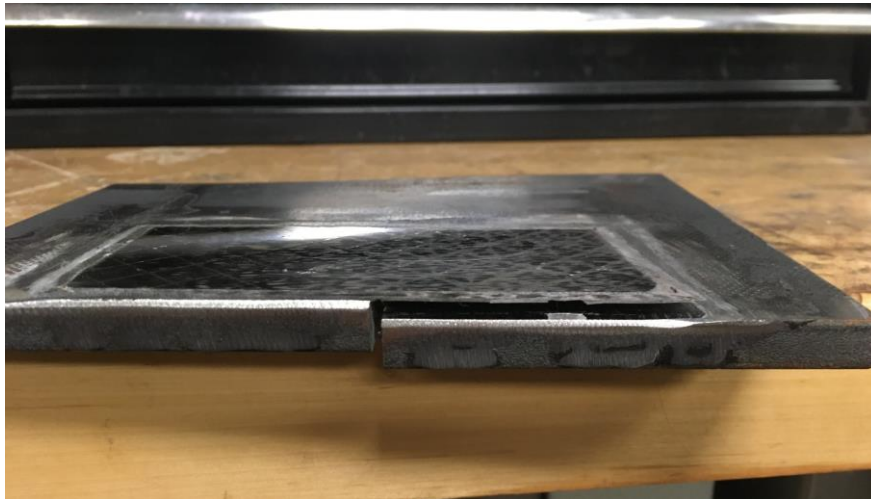
Combined stresses test on plates with CFRP retrofit was run three times. The number of cycles at which each specimen failed was 49,259, 80,862, and 73,012 respectively, compared to 46,326, 79,240, and 95,424 cycles to failure with no retrofit. This implies CFRP did not have much effect in preventing crack development under combined axial torsional stresses. One of the reasons that can explain this result is that the retrofit partially peeled off from the steel plate. As the CFRP retrofit used in this project was a thin plate, part of it was separated from the steel plate due to the deformation generated by torsion (see Figure 10).

Figure 10. A Steel Plate with CFRP Retrofit After Combined Axial-Torsional Test
