**Optimization of the Practice of Slow Cooling Steel Bars:
A Redesign and Modernization of Materials**

An Undergraduate Honors College Thesis

Department of Mechanical Engineering

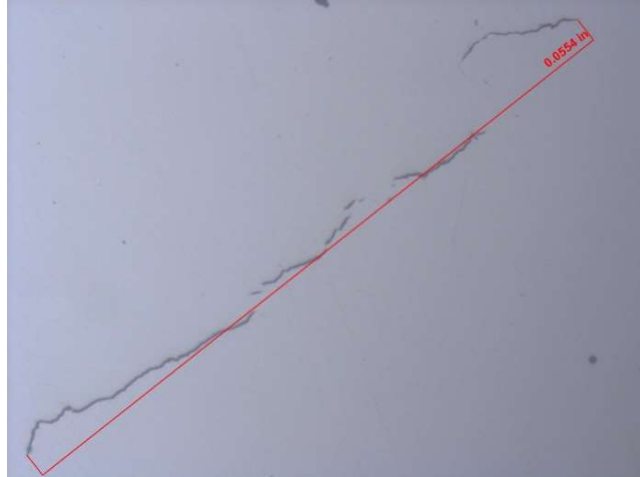
FIGURE 1: Hydrogen Flakes in a Steel Bar

In the early 1920's, flaking was documented as a defect formed due to the presence of hydrogen within steel and a multitude of research was completed following its discovery to determine the mechanism that causes the flaking. Hydrogen flaking is defined as “an extremely complex phenomena” (Fruehan, 1997) for which “the precise mechanism is not completely understood,” (Fruehan, 1997) but when simplified requires the presence of hydrogen and causes “internal hairline cracks, or shatter cracks, commonly referred to as (snow) flakes” (Fruehan, 1997). These cracks can be seen in Figure 1 below.

The presence of hydrogen causes these flakes because it “tends to concentrate in the discontinuities inside the material” (Ravichandar, Nagashanmugam, & Balusamy, Slow Cooling of Hot Rolled Bars to Eliminate Hydrogen Induced Cracks in Cr-Mo Steels, 2015). When the concentration of hydrogen is high enough, and the cooling rate is too fast, the hydrogen “can recombine to molecular hydrogen and create very strong localized pressures,” (Ravichandar, Nagashanmugam, & Balusamy, Slow Cooling of Hot Rolled Bars to Eliminate Hydrogen Induced Cracks in Cr-Mo Steels, 2015) and in turn, these pressures can “exceed the strength of the steel and cause fractures or hydrogen flakes” (Ravichandar, Nagashanmugam, & Balusamy, Slow Cooling of Hot Rolled Bars to Eliminate Hydrogen Induced Cracks in Cr-Mo Steels, 2015). These hairline cracks weaken the steel, decreasing its capacity for load bearing and increasing the brittleness of the steel. This is especially crucial since the most vulnerable types of steels to hydrogen flaking are high-strength steels (Hydrogen Embrittlement, n.d.). For companies looking to buy a high-strength clean steel, hydrogen flaking can be detrimental to their processes. Therefore, companies that produce specialized steel must ensure that there is no hydrogen flaking within their bars to guarantee that the quality matches the customer specifications. When bars are inspected, and hydrogen flaking is found, the bars are scrapped, as the defects within the steel do not allow it to be a useable product. In turn, this creates a large cost for the company if the flaking is not eliminated within the processing of the steel.

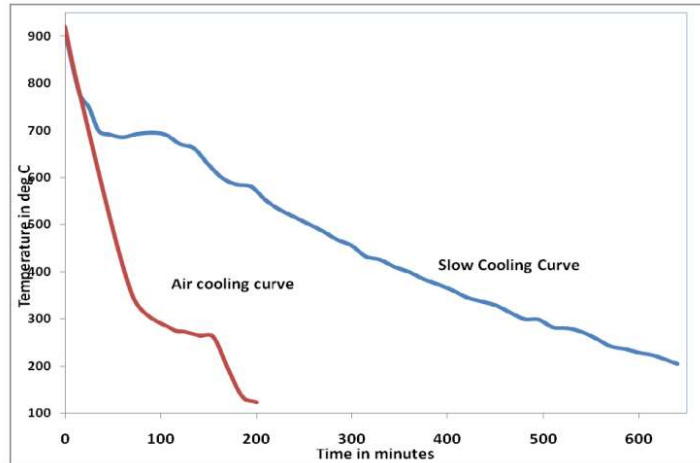
FIGURE 4: Temperature Profiles of Air and Slow Cooled Bars

In addition to temperature, the time for hydrogen to fully dissipate through the steels is crucial for reducing the chance of hydrogen flaking as the process is intrinsically slow. “It may take 12 hours to 30 hours and even more depending on the size and hydrogen content of the steel” (Sarkar, 2016). This is shown in Figure 4 below in which the temperature profiles and time to cool of slow cooled and air-cooled bars are plotted (Ravichandar, Nagashanmugam, & Balusam, Elimination of Hydrogen Induced Cracks by Slow Cooling After Hot Rolling of Medium Carbon Molybdenum Steel Blooms, 2014).

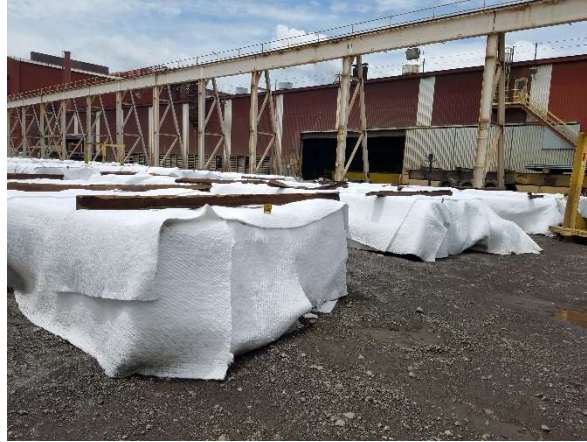
FIGURE 6: Steel Bars Slow Cooling under a Blanket

The design of materials began by a discussion with the company about different options available to slow cool the steel bars. Many plants use “boxes” such as the one below in Figure 5, (Dhakshanamoorthy, Bommannan, & Thangavel, 2016), while others lay different materials over the steel as a “blanket” as shown below in Figure 6.

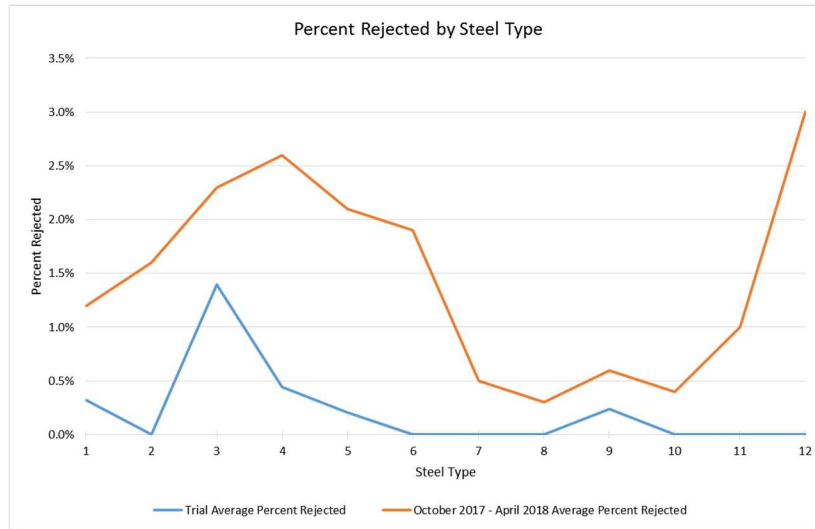
FIGURE 10: Percent of Centerline Rejects by Steel Type

The next requirement of the project was to improve or maintain the quality of the steel bars. To do this, the testing data for the number of bars that were rejected due to center line defects from the trial heats were surveyed in contrast to the testing data from the heats produced under normal conditions. The top 12 types of steel in the trial were initially examined in comparison to the normal heats of the same steel type to gain an overall understanding of the situation, as shown in Figure 11 below. Individual trial data in regards to centerline rejects can be found in Appendix F, Figure F1. One heat was eliminated from the data as a multitude of variables other than the trial that could have caused an increase in centerline defects were identified in relation to the heat.

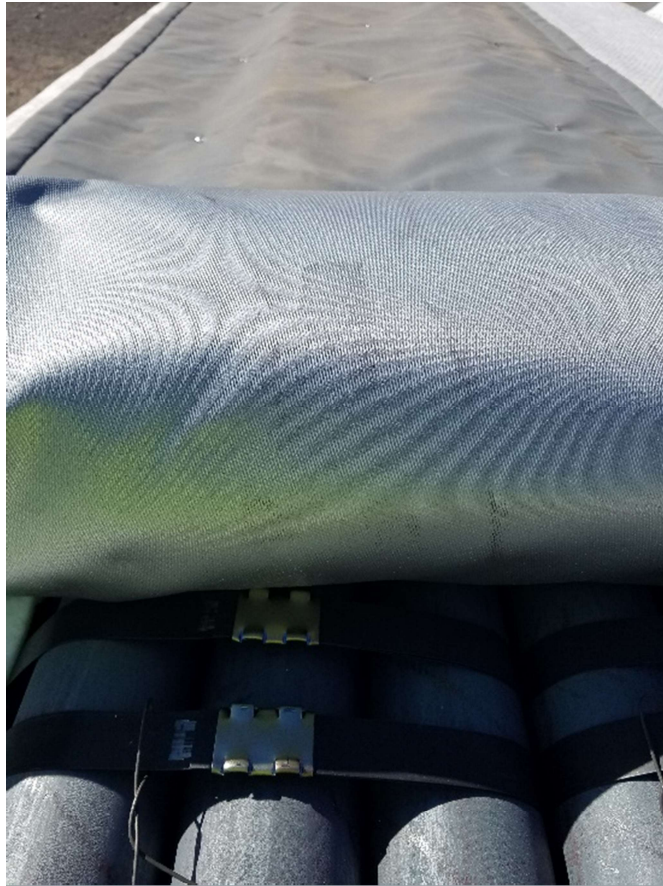
FIGURE C3: Material 2 Photograph 1

Material 2 also performed well in the first trial. The size of the sheet, however, seemed too large for the employees to easily handle. Both materials had scorch marks after being removed from the steel, but were easily removed by rubbing them with a small amount of water. Moreover, storing the material was troublesome as the material had to be rolled and then stacked on a pallet. This could become an issue due to the weight of the material and the chance that a single employee may have to handle the material alone.

Material 2 also did not tear during the trial. The workers liked the idea that this material might be able to interconnect over the heats using the hooks that were incorporated in to the construction of Material 2. Along with this, the workers liked the size of the material. It was heavier, but it's large size made covering a heat faster as the employees had to place less sheets of material on the steel. Some black streaks also appeared on Material 2 during this trial, but like on Material 1, they rubbed off easily.

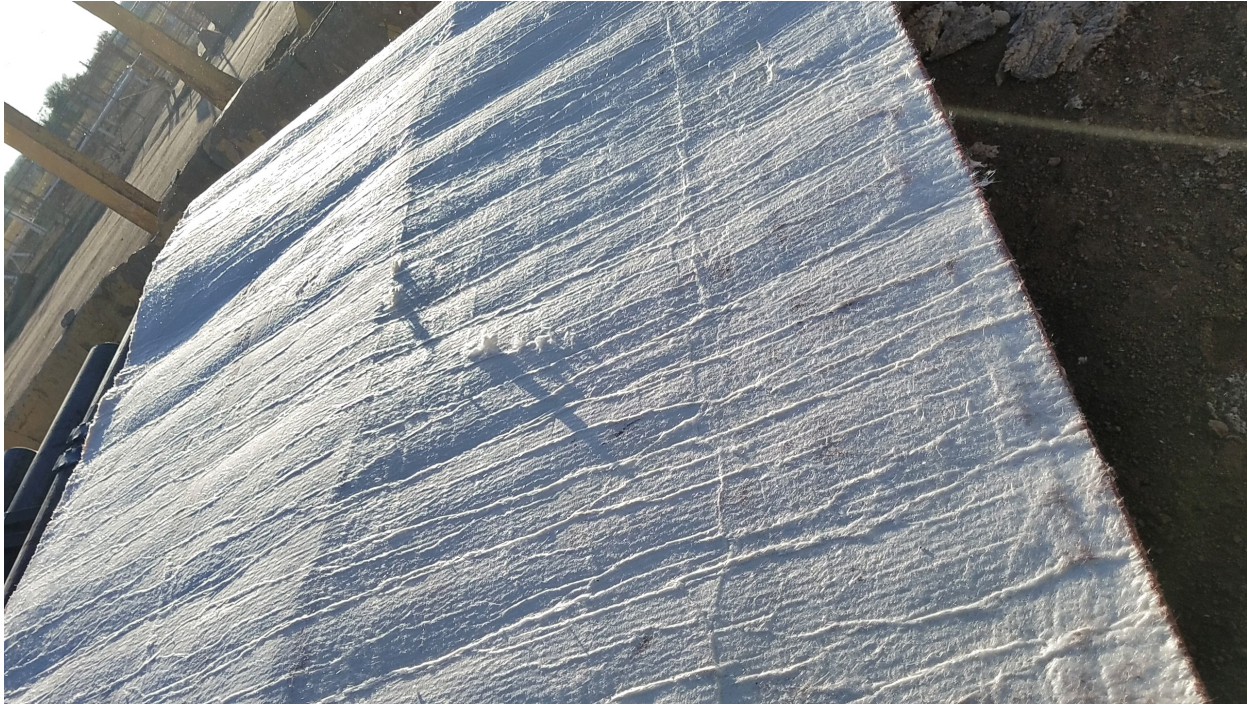
FIGURE C5: Material 3 Photograph 1

Material 3, which was like the original material with the addition of a waterproofing coating, held up through the first trial. Of note, this material let off a strange dust when being rolled and began to deteriorate, creating a fibrous dust similar to what the original material produced when handled. The material also absorbed dirt from the ground and had a few minor scorch marks. These issues caused the employees to be wary of the material and its future abilities.

Material 3 was not preferred as it absorbed dirt and tore easily when rubbing against the bars. This material was removed from testing after this trial because the waterproof coating on the material was compromised and the material began to absorb water. Along with this, there were some safety concerns from the workers, due to the residue it was leaving on their clothing and the fibers it was releasing into the air when being rolled up and placed into storage. There were also concerns about the Safety Data Sheet of this material as many of the hazards listed had a statement next to them asserting the fact that the material not been tested. Finally, the material was easily damaged after rolling and storing it multiple times.

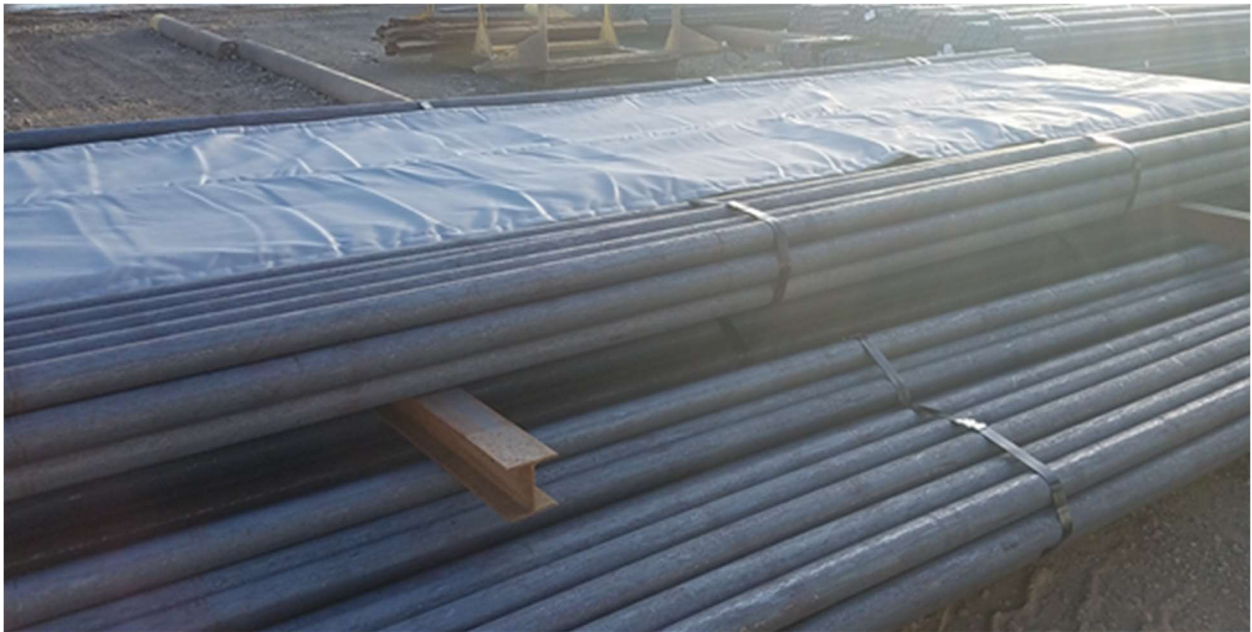
FIGURE C8: Material 4 Photograph 2

After 5 trials of Materials 1 and 2, Material 4 was introduced to the project. This material underwent the same initial trials to determine the viability of its use, and it passed. This material was composed of a waterproof outer layer, insulation, and heat resistant inner layer that was not waterproof. After the 3rd trial of Material 4, the material became waterlogged and was eliminated as a possibility for this project. Subsequently, it was also determined that Material 1 had better insulative properties than Material 2 and weighed less per square foot making it easier to handle.

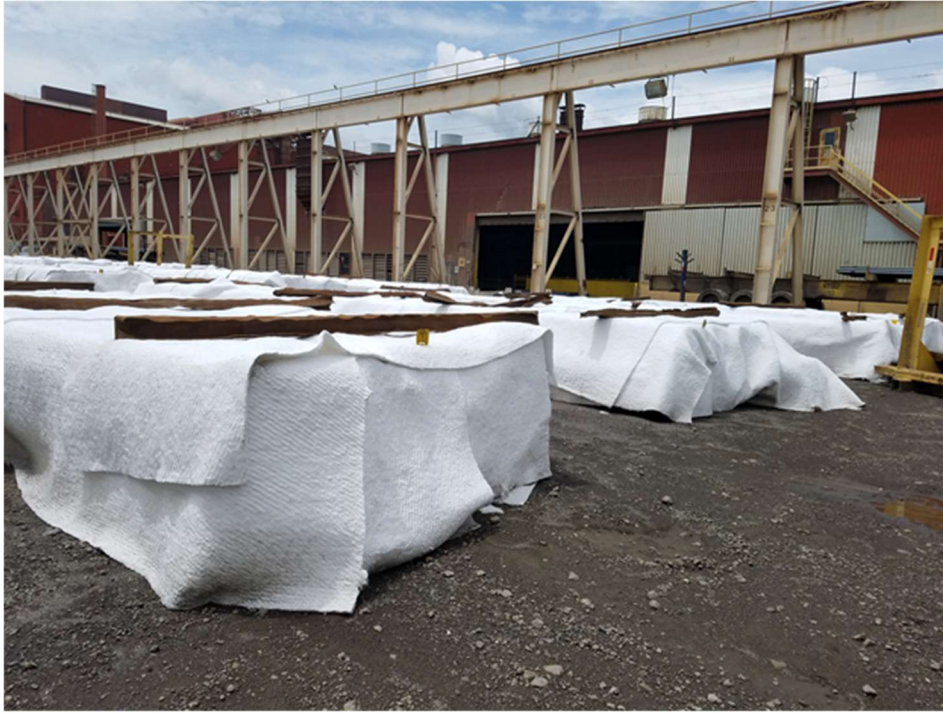
FIGURE C11: Original Material Photograph 1

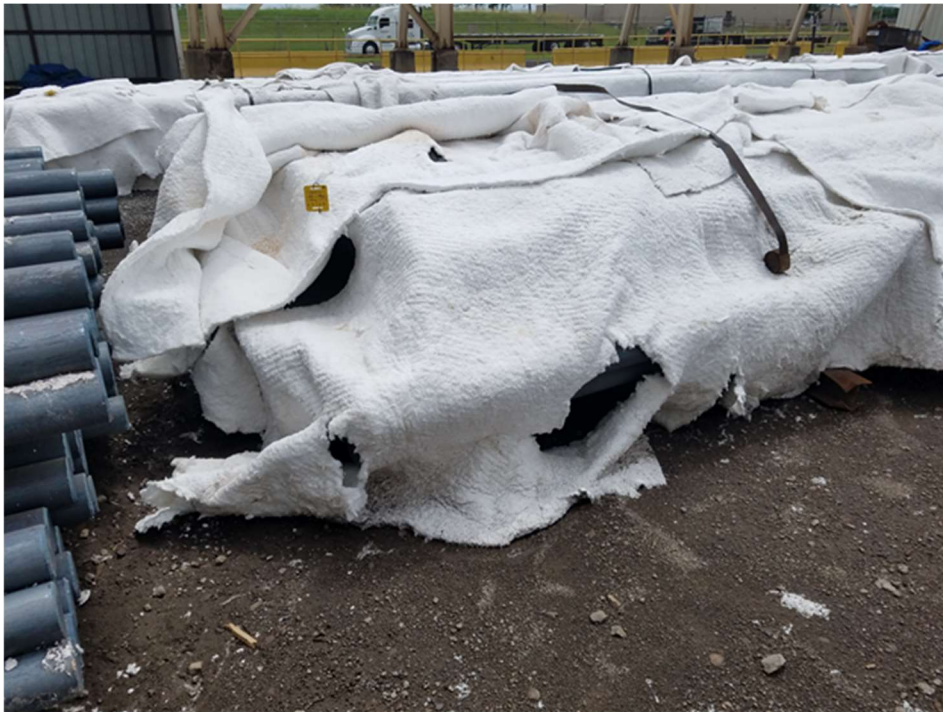
FIGURE C12: Original Material Photograph 2

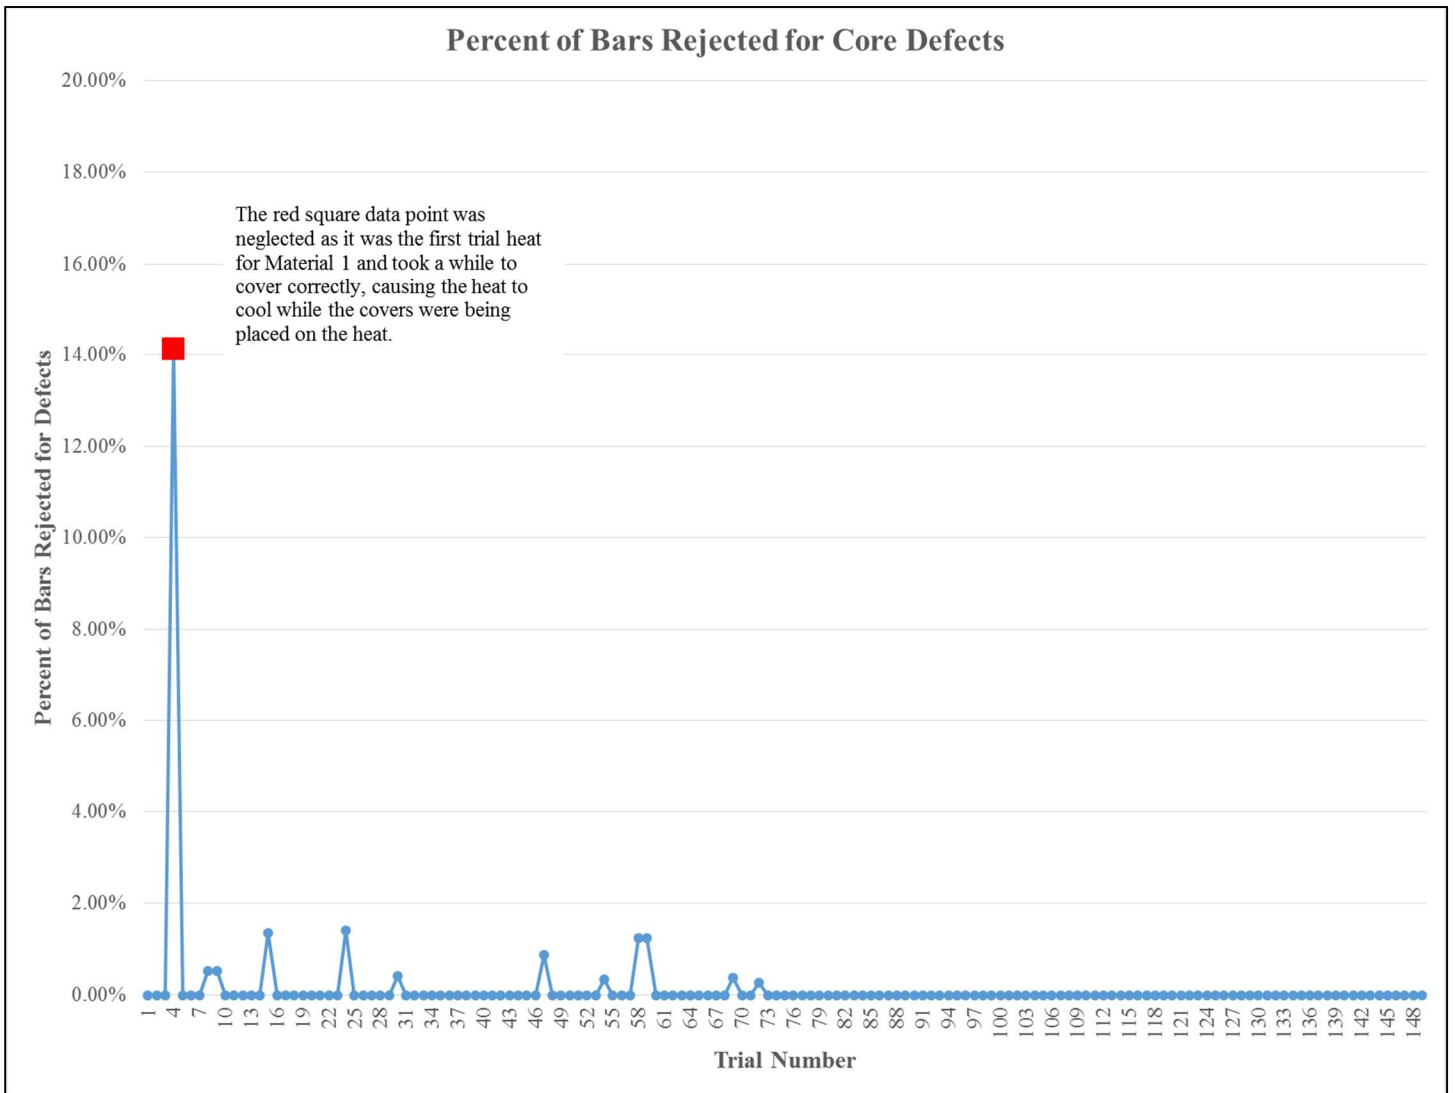
FIGURE F1: Percent of Bars Rejected for Core Defects
