Distribution Map of Multi-Walled Carbon Nanotubes in a Refrigerant/Oil Mixture Within a 2.5 Ton Unitary Air-Conditioner

Warren Russell Long
University of Arkansas, Fayetteville

A thesis submitted in partial fulfillment
of the requirements for the degree of
Master of Science in Mechanical Engineering

December 2012
University of Arkansas

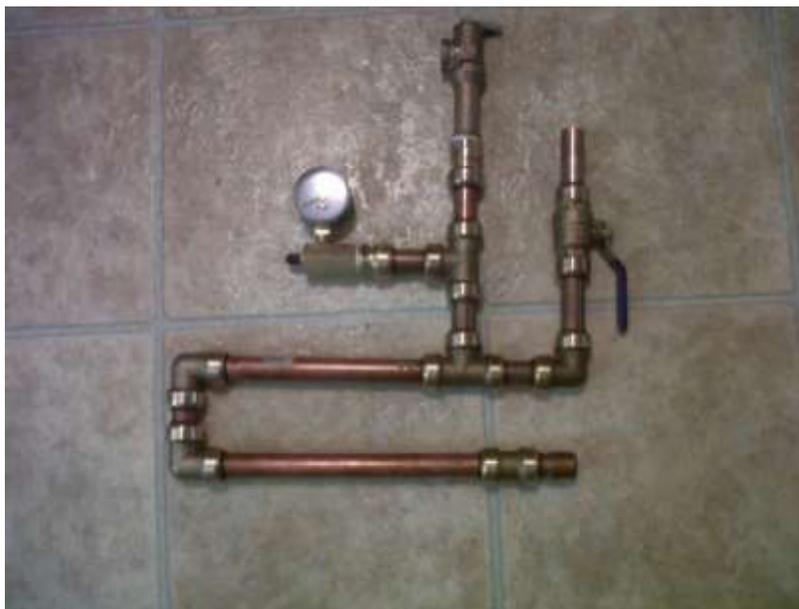
Figure 1. Device designed to test the tendencies of CNTs during evacuation of refrigerant.

Because the primary experiment would require the refrigerant to be evacuated, two preliminary tests were run using a simple apparatus (Fig 1). The device utilized copper tubing, quick release connections, a pressure gauge, a pressure relief valve, and an exit valve. These tests were used to determine if the nanoparticles would remain in place while the primary test apparatus (2.5 ton (8.79 kW) unitary air-conditioning system) was evacuated at the end of its operation. R-113, MWCNTs, and a small amount of POE oil were inserted into the arrangement. The valve was closed and the device was heated by a hot water bath to about 180 F (82.2 C),

well above the boiling temperature of R-113, 117.7 F (47.5 C). Although it was assumed that a rapid release of the refrigerant from the device would greatly disturb the position of the CNTs, and they would likely exit through the valve, the assumption needed to be verified. The device was held in the hot water bath until the pressure stabilized; then the valve was quickly and fully opened. The very small amount of remaining CNTs were weighed, and, as hypothesized, most CNTs had been expelled from the arrangement.

The purpose of the second test was to determine if the CNTs could remain undisturbed from their position during slow evacuation of the refrigerant. The same methodology was used as before, except after the addition of the refrigerant, CNTs, and oil, a swath of white cotton cloth was placed over the exit tube. The device was heated again. This time the valve was opened just enough to audibly verify that refrigerant was escaping. After all refrigerant was expelled, the device was inspected. Quick release connections were used in the assembly in order to facilitate ease of inspection. The cloth showed no visible evidence that any nanoparticles were carried to the exit valve by the refrigerant, as the white cloth was unblemished by CNTs. Also, the stem

leading up to the valve, and the valve itself, had no sign of any CNTs on their walls. The CNTs and POE oil were left in a continuous channel at the gravity bottom of the tubes. This verified that refrigerant can be evacuated while leaving the nanoparticles relatively undisturbed. Also, it was found that a methanol flush of the tubes worked very well in removing the oil and CNTs.

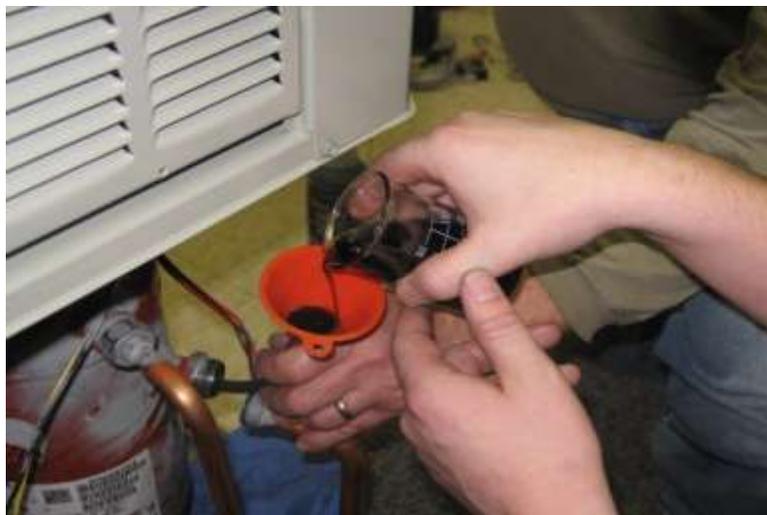
Figure 2. Pouring CNT/oil mixture into the scroll compressor by way of funnel and tube.

Prior to the insertion of the CNTs, ultrasonification within the POE oil was used to eliminate agglomeration. Of the 675 mL (2.85 cups) of oil removed from the compressor, 500 mL (2.11 cups) were used as the host to the CNTs for ultrasonification. Six grams (92.6 grains) of CNTs were ultrasonified within the POE oil medium for 20 minutes. Within 45 minutes of its removal, the oil/CNT mixture was reinserted into the compressor by way of funnel and tube (Fig 2). The 175 mL (0.74 cups), and an additional 200 mL (0.85 cups) of oil were used to flush residual CNTs into the compressor. This system normally utilizes 4.2 cups (994 mL) of oil; the addition of 200 mL (0.85 cups) creates a total of 5.05 cups (1194 mL) of POE oil in the compressor. This is an excess oil percentage of about 19%. POE oil has a density of 0.98 g/mL (8.18 oz/cup); therefore the total mass of oil used in this experiment was 1170 g (41.3 oz). Six grams of CNTs were used in this experiment; the mass percentage of CNTs/oil was found to be 0.51%. No surfactants or stabilizers were used.

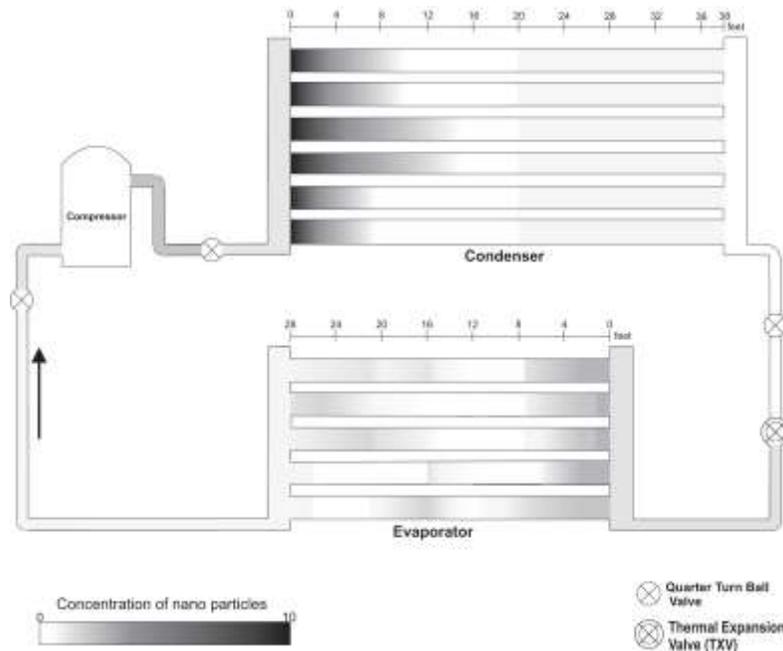
Figure 3. Schematic showing the presence of CNTs (of varying degrees of adhesion) found throughout the vapor compression unit. Though a significant amount of CNTs were recovered from the compressor, this section of the schematic is not shaded due to the fact that the compressor has a much different layout than the rest of the system and does not conform to the basis of the CNT density approximation. See Table 2 for the quantities of CNTs recovered through system/component flushes.

Figure 3 is a simplified sketch of the packaged unitary air-conditioner used. Shading throughout the diagram was used to show the relative amount of CNTs throughout the system immediately after shutdown and the refrigerant removal (i.e. evacuation) step. A relative scale of '0-10' was used. These 'scores' were awarded on a relative, linear basis. Even with different types of tools it wasn't possible to remove all CNTs from the walls, especially in the condenser tubing. Enough could be removed, however, to obtain an estimate for a rating of '10'. This score corresponds to approximately 0.1 grams of CNTs discovered per foot of tube (0.33 g/m or 1.54 grains/ft) designated as such. While the condenser fouling displayed very strong adhesion, some portions, such as the section between the evaporator and compressor, showed weaker adhesion and were able to be removed by a single methanol flush. Figure 4 shows the schematic of the system *after* flushing, and indicates the sections where CNTs were more strongly adhered. Table 2 shows the mass balance of both CNTs flushed from various system components and approximated values for strongly adhered CNTs that were not able to be removed by flushing. Following is an explanation of the results.

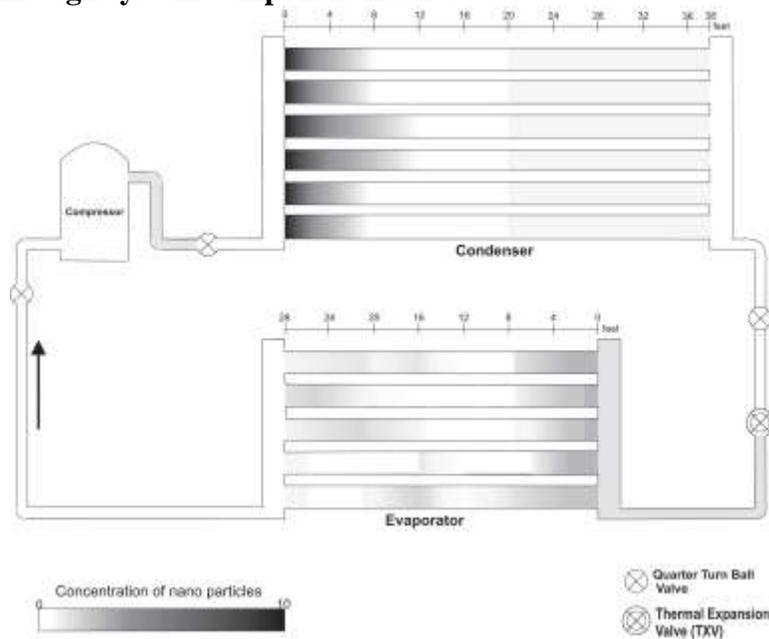
Figure 4. Schematic showing the presence of strongly adhered CNTs found throughout the vapor compression unit. The shading in this diagram indicates the relative density of CNTs *after* flushing. Note the differences between Fig 3 and Fig 4; especially notable is in the discharge and suction lines.

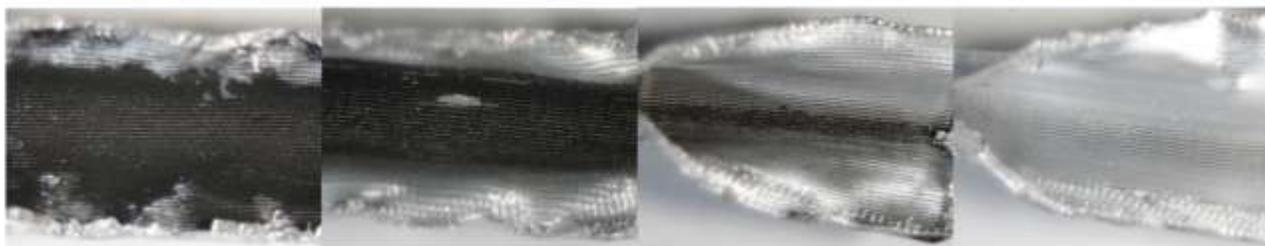
Figure 5. Condenser circuit one at 6 inches (0.15 m); 5 feet (1.5 m); 7 feet (2.1 m); and 10 feet (3.0 m). Each segment is approximately one inch (0.025 m) in length. The leftmost segment initially had complete circumference coverage; this coverage declined to a stripe before being completely devoid of CNTs.

The 3/16 inch (4.76 mm) inside diameter copper tubes from the pre-condenser manifold transitioned to 3/16 inch (4.76 mm) aluminum tubes with interior axial ribs. One of the most unexpected results of this project was the dramatic immediate increase in adhered CNTs once the aluminum condenser section began. The nanoparticles completely coated the entire circumference of the tube to the point that it was very difficult to discern the peaks from the valleys of the ribbed inside. The beginning of each of the six condenser circuits were very similar, and were all rated as a ‘10’ in Fig 3. As noted previously, this rating is estimated at 0.1 g/ft (0.33 g/m or 1.54 grains/ft) of condenser line. The fouling eventually diminished to just a ‘stripe’. Where the area fouling did occur in the condenser, it was found to have an area density of approximately 1.6×10^{-5} grams per square millimeter (0.16 gr/in^2). In all six circuits the concentration of CNTs decline to zero at a maximum of 15 feet (4.6 m). Figure 5 shows

representative images from condenser circuit one at four different points within the first 10 feet (3.05 m); each image length is about one inch (25 mm). As can be seen, the fouling began as total circumference coverage but became increasingly localized ending in a thin ‘stripe’, but not at the gravity bottom of the tube. It seems that once the refrigerant has condensed, it is much more successful in carrying the CNTs through the system, with minimal fouling. The middle third section of each condenser circuit was virtually devoid of CNTs, but the last third of each circuit did have a very small amount of nanoparticles stuck to their walls: as much as 1.6×10^{-6} grams per square millimeter (0.016 gr/in^2). Aside from that, the latter two-thirds of the condenser was unremarkable in terms of clinging CNTs.

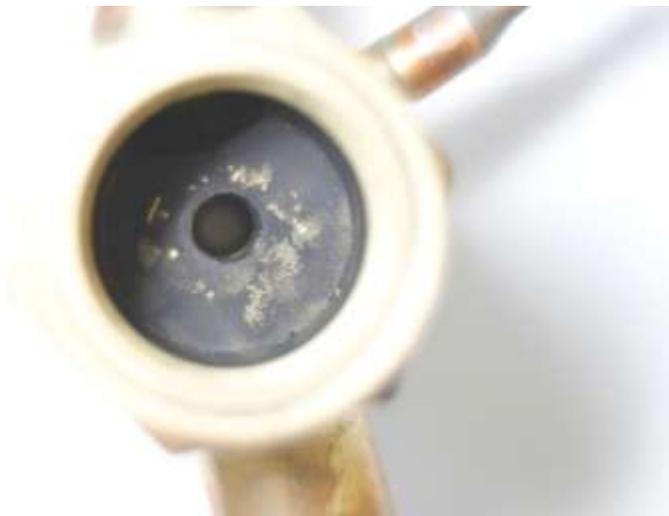
Figure 6. View into the interior of the TXV.

The thermal expansion valve was the next component to be investigated. The upstream two feet (0.61 m) of pipe had no CNT fouling. The inside of the valve was entirely coated with a light film of CNTs (Figure 6), as were the very small 3/32 inch (2.4 mm) inside diameter tubes

(downstream of the TXV) leading into the evaporator. The area density of these small tubes was about 7×10^{-6} grams per square millimeter (0.07 gr/in^2). This was a significant discovery because the tubes leading to the evaporator are very small and in time could have significant blockage with nanoparticles. This was the first low-pressure (i.e. relatively cold) location of the system where the CNTs were found stuck on the inside of the tubing walls.

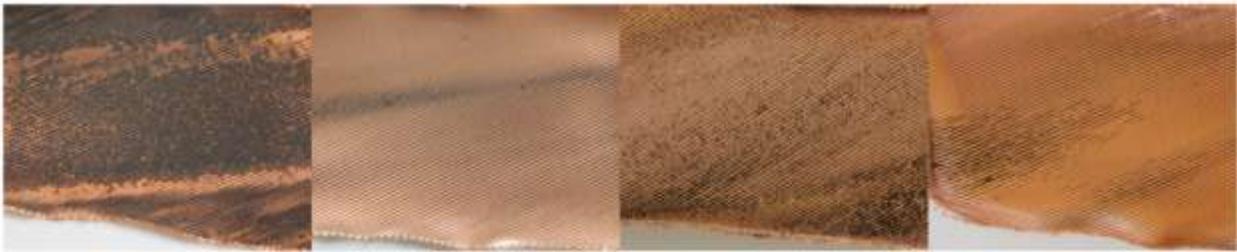
Figure 7. Images of inside tube surfaces from the third evaporator circuit. Left to right: 2 feet (0.61 m); 8 feet (2.4 m); 17 feet (5.2 m); and 26 feet (7.9 m). All measurements from inlet of the evaporator.

The evaporator section was evaluated next. Based on what had been observed thus far, it was expected that the end of each evaporator circuit would provide the best possibility of CNT fouling (since the refrigerant would be a superheated vapor); however, this was not the case. In order to obtain a clear picture of the fouling tendencies, each of the five evaporator circuits was sampled at 12 locations along the length. It was found that the greatest concentrations of nanoparticles were at the beginning of each evaporator circuit. The CNTs were not as concentrated as they were at the beginning of the condenser circuits, but the first 3-4 feet (0.9-1.2 m) of each circuit could account for as much as 0.1 grams (1.54 grains) of clinging CNTs apiece. The area density in this area was approximately 8×10^{-6} grams per square millimeter (0.08 gr/in^2). Beyond 4 feet (1.2m), concentration of CNTs quickly decreased. In some of the mid-

evaporator circuits (i.e. middle third), there was no sign of CNTs; yet in other circuits, though not nearly as concentrated as the beginning of the evaporator, there were CNT deposits, as Figure 3 shows. It was not the case for every circuit, but in general, the latter third (~9 feet (2.7 m)) contained more CNTs than the middle third. The only consistency found in the evaporator was that the first few feet were moderately fouled in each circuit. The position of each circuit, and individual tubes, were cross referenced to each other to find if position in the evaporator influenced the fouling. No correlation was discovered. Figure 7 shows four samples from evaporator circuit three. This circuit is approximately the average in terms of the fouling at each point.

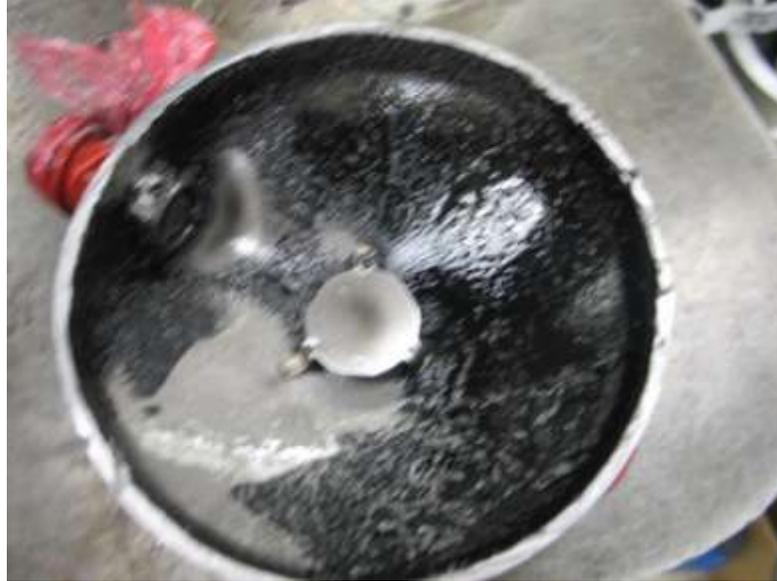
Figure 8. High pressure dome of the scroll compressor. A thick coat of CNTs and POE oil cover most of the dome.

Lastly, the compressor was closely evaluated. After the compressor was disconnected from the system, the POE oil/CNT mix was poured out of the low pressure inlet; this was the same port used to insert the mixture into the compressor (Fig 2). The bottom section (i.e. low pressure portion) of the compressor was flushed with R-113 three times to remove as many CNTs as possible. On the third flush, the liquid refrigerant flush was clear. Next, the compressor's high pressure 'dome' was removed with a band saw. As can be seen in Figure 8, CNTs and oil coated the interior of the dome. To be in that location, they had to have come through the scroll assembly of the compressor, along with the refrigerant and oil. See table 2 for the mass of CNTs collected from the compressor's high pressure dome.

A second cut removed the scroll assembly from its motor and oil sump. There were traces of CNTs and oil in this area: on the motor windings, interior walls, and even inside the internal electrical connection. However, it cannot be definitively said that the pouring of the oil/CNT mix did not contribute to the CNT coating in this area of the compressor. On the other hand, the extent to which the dome was coated and the fact that so many CNTs were found throughout the system, clearly displays that nanoparticles can and do leave the scroll compressor during operation.

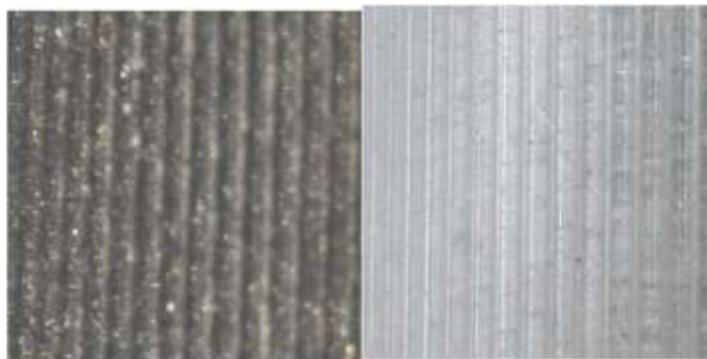
Figure 9. Close-up comparison of 3x3 mm (0.118 in. x 0.118 in.) sections of condenser circuit one. Left: 6 inches (0.15 m) into the circuit; Right: 10 feet (3 m) into the circuit.

If nanoparticles are to be used in a standard vapor-compression system with no modifications, a pressing question needs to be answered: Will the heavy fouling found in the first few feet of the condenser continue to progress farther and farther down the condenser line? The extent of the fouling found at the outset of the aluminum condenser, though not tested, seems to strongly indicate that heat transfer capabilities may be handicapped. The left side of Figure 9 shows a close-up (3 mm x 3 mm (0.12 in. x 0.12 in.)) of the fouling that is representative of the first few inches of each condenser circuit. The right side of Figure 9 shows a close-up of the same dimensions of the same circuit at 10 feet (3 m) into the circuit. Recall, based upon the entirety of the condenser, the fouling is strongest in the 100% vapor quality region and diminishes to virtually no fouling in the liquid refrigerant portion of the condenser. If the fouling inhibits heat transfer, phase change may occur later in the condenser, allowing nanoparticles a more favorable environment to adhere to the surfaces. This could cause a kind of ‘snowball’ effect, eventually fouling the entire length of the condenser and ceasing to properly condense the refrigerant.

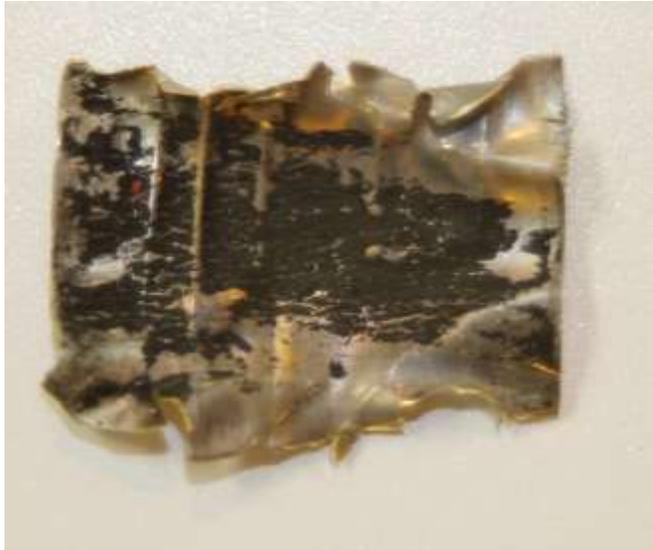
Figure 10. Image of CNT buildup on the one inch transition piece from copper tube pre-condenser manifold to aluminum tube condenser.

The first smaller diameter tubes encountered, in this mapping research, were the individual copper tubes leading from the pre-condenser manifold that were soldered to the aluminum condensing circuit. This entire section presents a possible difficulty. The individual copper tubes from the manifold did have some tightly adhered CNTs which, after a long runtime, may start to cause congestion problems, but they were not as worrisome as the transition from copper tube to aluminum condenser. In order to braze the transition from copper to aluminum, a thin, 1 inch (25 mm) insert of the same inside diameter is used to connect the two sections. This collar, upon inspection, had a substantial amount of clinging CNTs as shown in Figure 10. This transition, along with the previously mentioned build up of CNTs in the condenser could pose a significant fouling/clogging problem in this region.

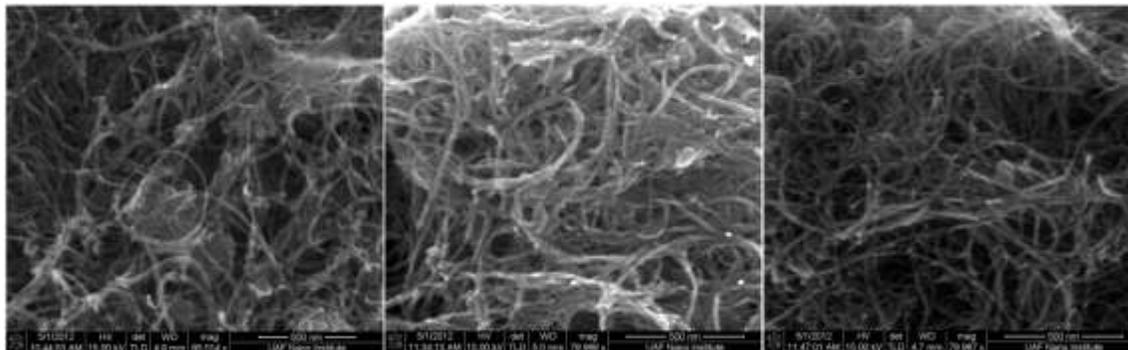
Figure 11. Scanning electron microscope (SEM) images of CNTs. Left to right: removed CNTs after the 168 hour system test; ultrasonified CNTs not used in system test; and virgin CNTs as purchased.

A scanning electron microscope (SEM) was used in order to compare the CNTs that were gathered from the compressor after seven days in the system, against the CNTs that were ultrasonified and not used, and against the CNTs directly from the supplier (i.e., virgin CNTs). Figure 11 shows this comparison from left to right, respectively.

These SEM pictures show the CNTs as agglomerations, a consequence of the necessity to dry the samples before this type of electron microscopy image can be taken. Although direct, absolute comparisons cannot be made with these pictures, it can be said, with a high degree of
