Environmental Reliability of Thin Film Sealing on Thick Film LTCC

A thesis submitted in partial fulfillment
Of the requirements for the degree of
Master of Science in Microelectronics-Photonics

Charles R. Bourland
University of Arkansas
Bachelor of Science in Electrical Engineering 2013

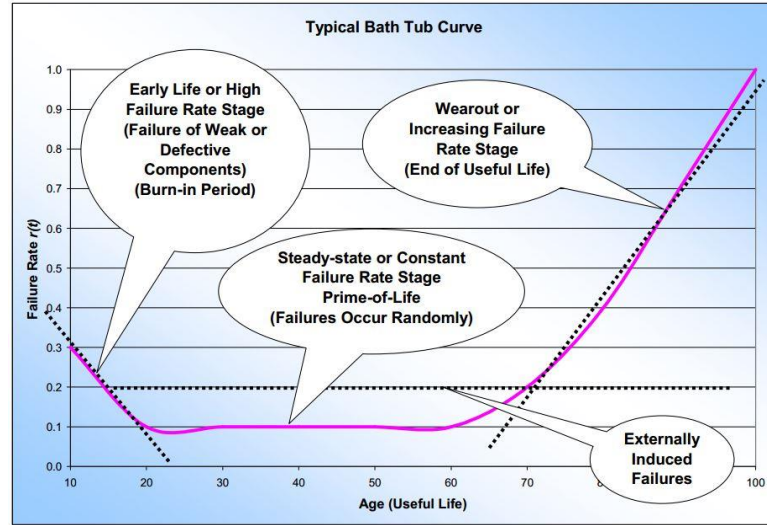
Fig. 2.3. Illustration of a typical reliability bath tub curve [13].

Reliability testing also helps designers and manufactures decide when and for how long to set warranties and manage statistical quality control [14]. In reliability theory, there is a graph known as the bath tub curve; this curve is shown in Fig. 2.3. In the short term there is an elevated chance for having an early failure caused by a defect, it is at this point where manufactures want to set their initial warranty periods. Following that shorter time is a much longer time referred to as the timespan of normal use, or steady state reliability. The final stage of the bathtub curve is from wear out failures, when the part has reached its end of life. At this point the item may still be functional, but the chances of catastrophic failure increase rapidly. Another use for the bath tub curve in addition to warranty information is that of mission duration. Take, for example, a space exploration mission where components need to last a minimum of 10 years.

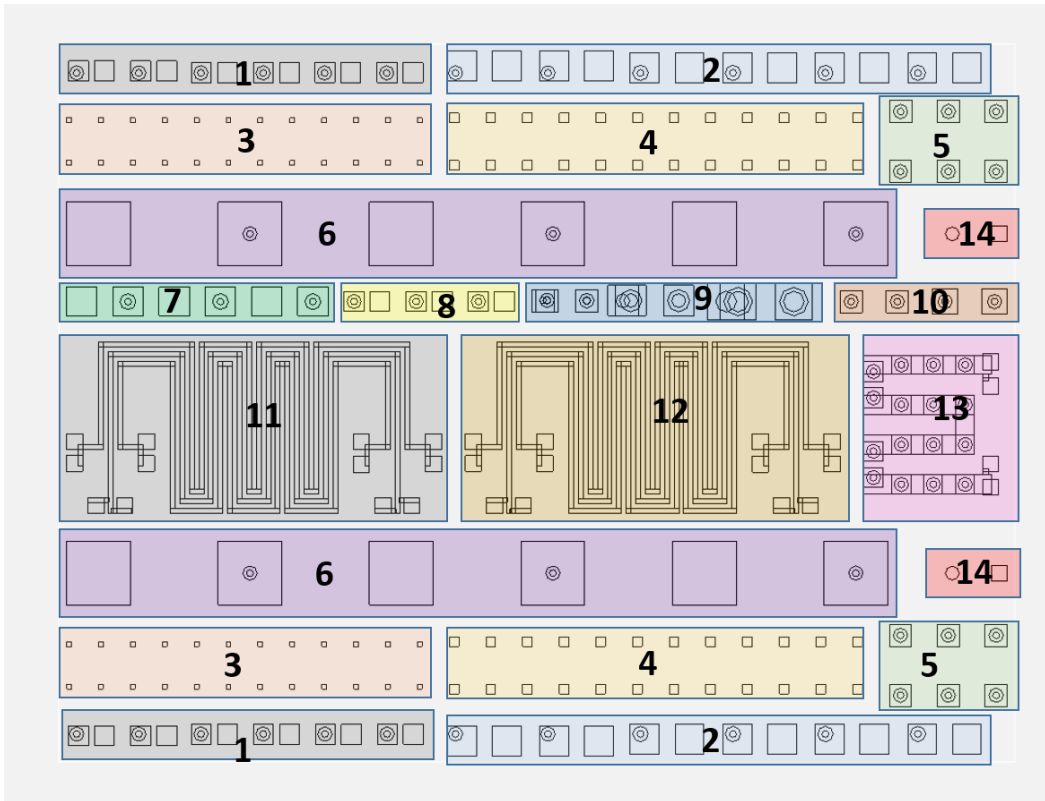
Fig. 3.2. The 14 feature groups on the LTCC Coupon 1 design.

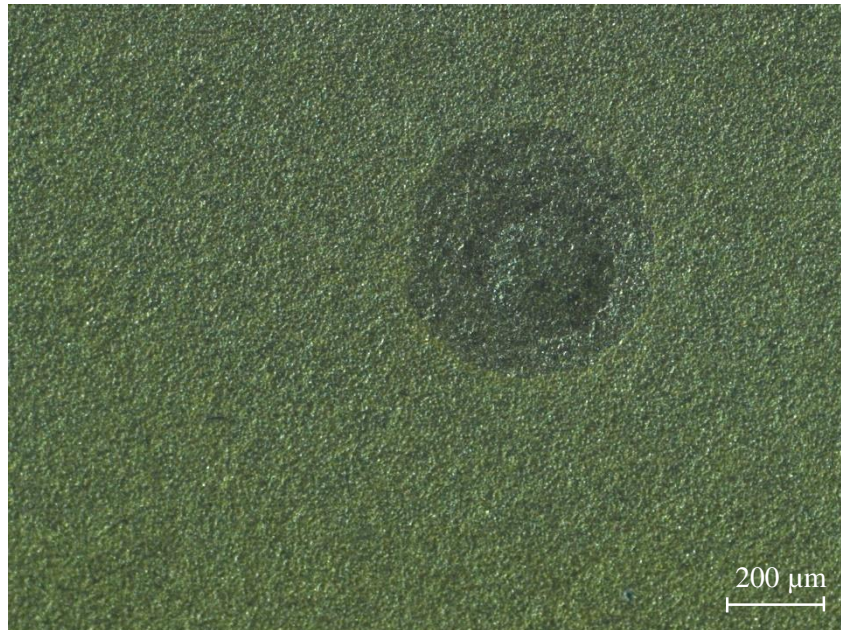
Fig. 5.16. A pristine via covered with large pin pull test pad.

Fig. 5.16 shows feature group 6, which are large pads with and without vias for pin pull testing. Fig. 5.17 shows the beginning via for the daisy chain in feature group 13.

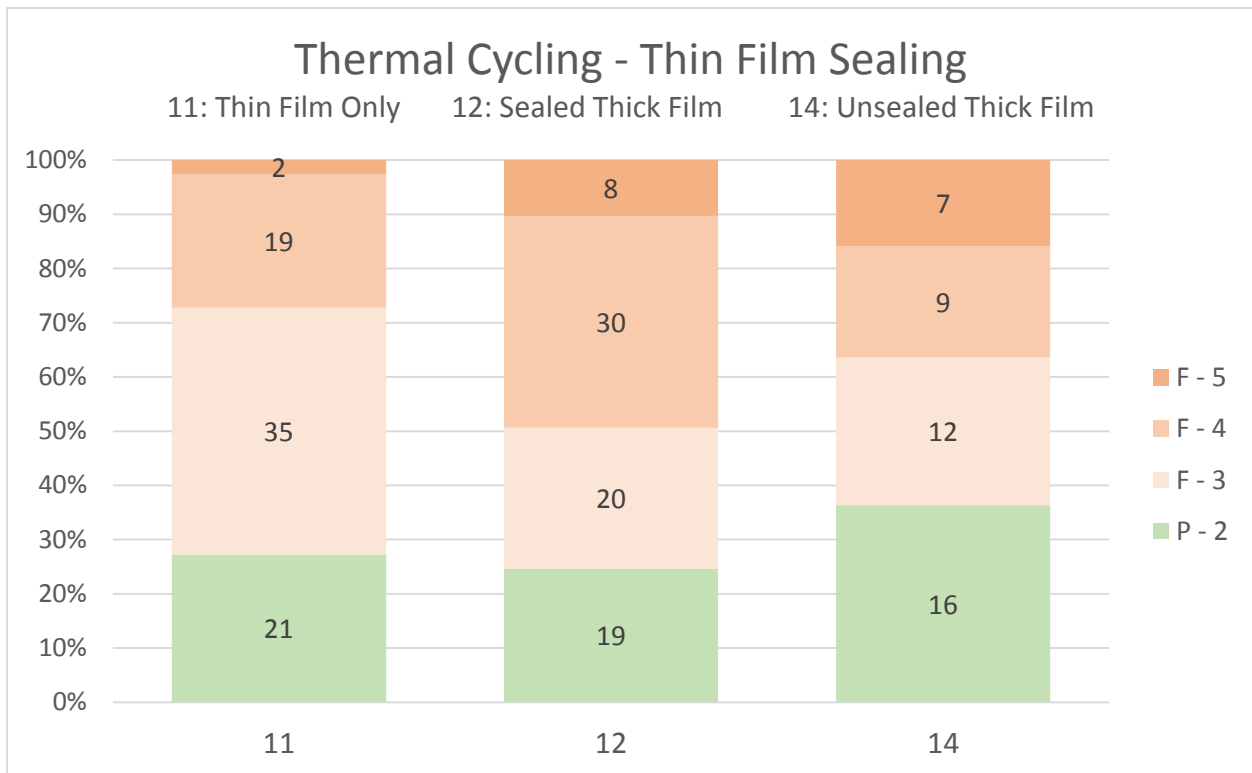
Fig. 5.40. The thermal cycling thin film sealing comparison at 1,000 cycles.

Fig. 5.40 compares three feature groups: group 11 which was thin film directly on the LTCC substrate, group 12 which was thin film sealed thick film, and group 14 which was the unsealed and exposed thick film elements. Note the difference in resolution (number of data points per column) of group 14, which was much lower resolution than the other two groups as there were only two data points per coupon for feature group 14. Regardless, the pass and fail rates of the three groups were similar. It was of key interest to note that the thick film elements in group 14 actually were more reliable in this test than either the thin film direct on ceramic or the sealed thick film.
