An Architectural Analysis of Caddo Structures at the Ferguson Site (3HE63)

A thesis submitted in partial fulfillment
of the requirements for the degree of
Master of Arts in Anthropology

July 2015
University of Arkansas

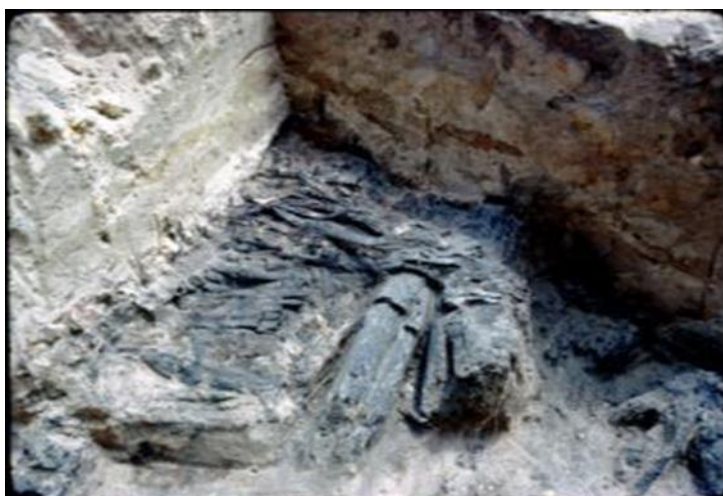
Figure 11: Charred wall matting atop wattle and some logs "A-3 house," Md. A (SAU1972-1092: Schambach 1972)

woven matting was fixed on the outside of the walls during use. Similar matting was also part of the superstructure of the A-3 structure (Figure 12). It was established that no roof remained with the carbonized superstructure debris. It is assumed the roof was removed before the building was destroyed by burning and burial because there was no evidence of remains from the roof among the burnt superstructure or on the building's floor (Figure 15).

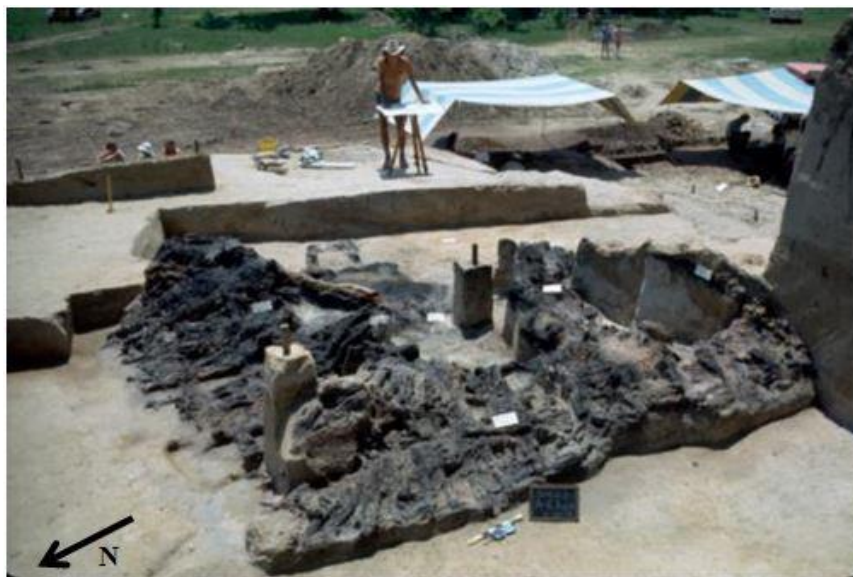
Figure 13: Slide of burned superstructure of “A-6 House” from the northwest corner (SAU1973-2132: Schambach 1974)

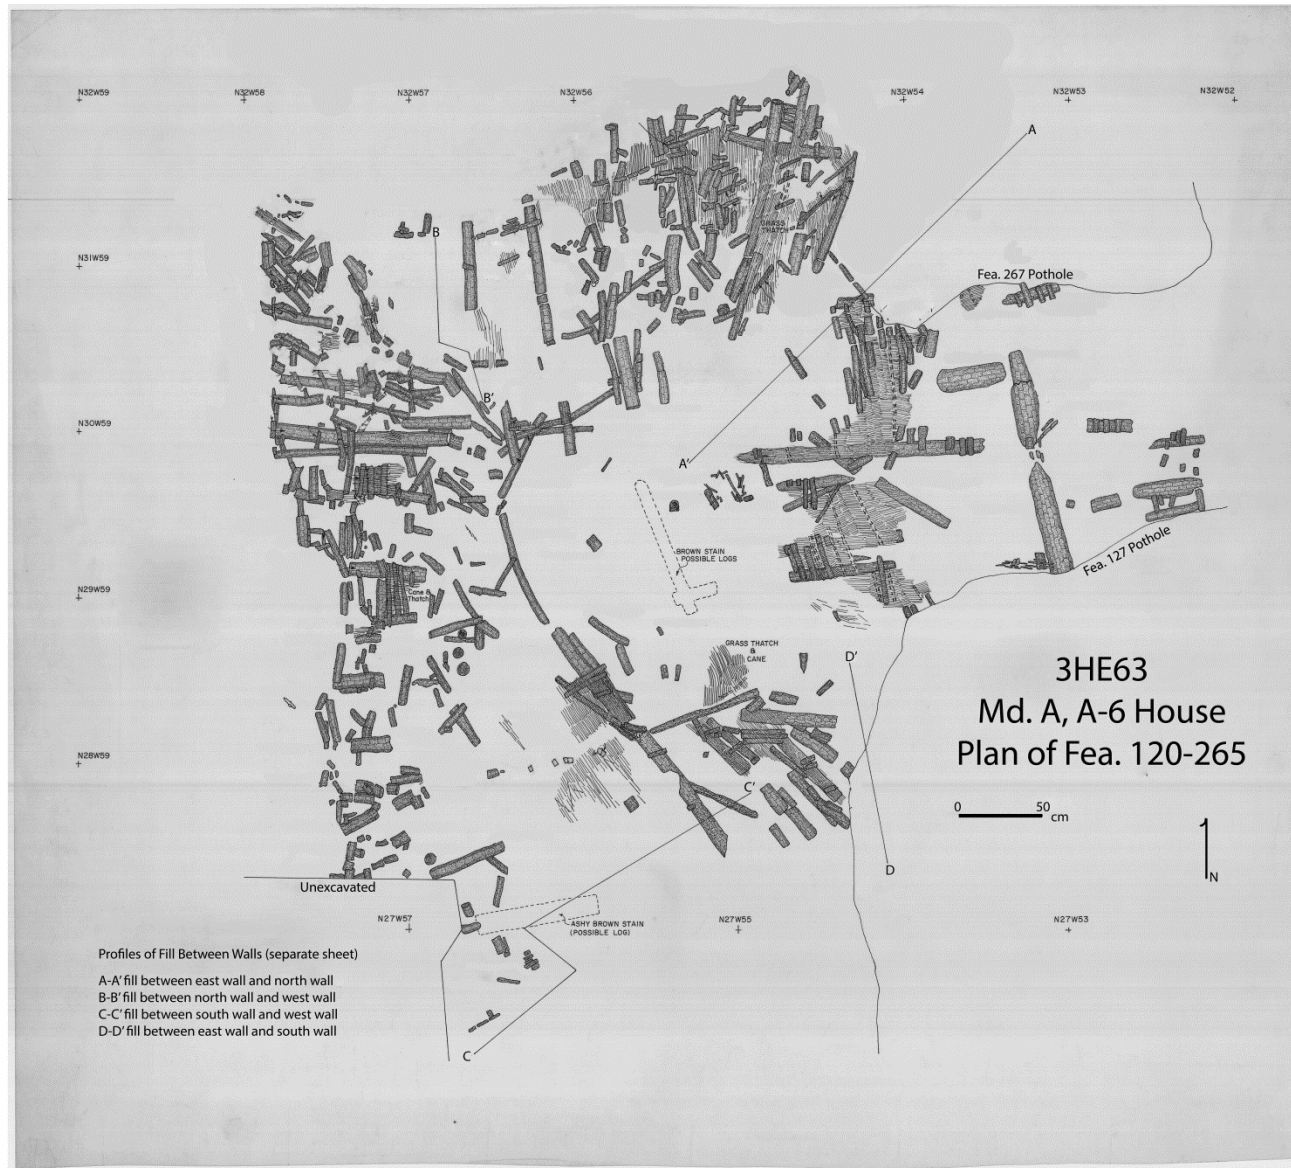
Figure 15: Md. A., “A-6 House:” Plan of Feature 120-265
 (Schambach 1974; original drawing by R. Taylor, D. Kelley, and C. McGimsey)

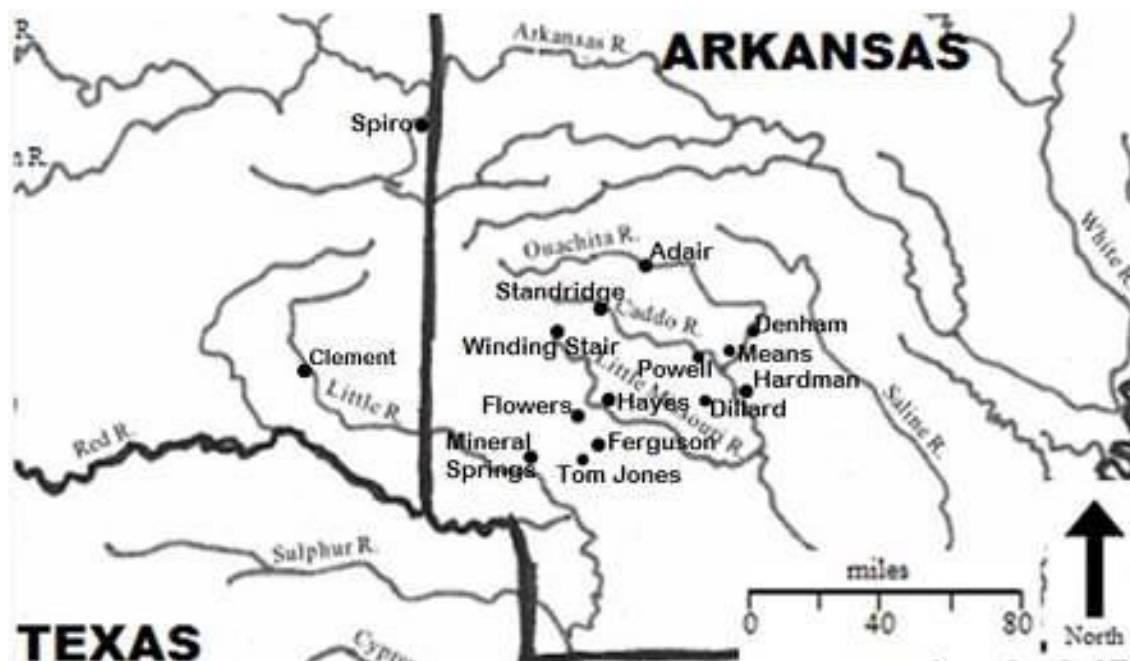
Figure 22: Caddo sites in the area

In this section I describe various structures throughout the Caddo archaeological region that have been identified as special-use (Figure 22). Perttula (2014) outlines reasons these have been considered special rather than domestic: the location of the structures on platforms is considered to be sacred and special, the structures are evenly spaced upon platform mounds, they generally lacked hearths, they do not contain much cultural debris, and some have extended entranceways. However, these buildings are not all found in association with mounds (Early, ed. 2000; Lockhart 2010), they are not all the same shape (Perttula 1996, 2009, 2012; Trubitt 2009), and they are not all oriented in the same direction (Perttula 2009). The one characteristic that most of these structures have in common is in their destruction through a ritual burning and burying that has been most recently analyzed by Mary Beth Trubitt (2009). Additional indicators of building use, as outlined by Early, are “The location of a building within a settlement—on a mound, for instance—the treatment it receives when it is abandoned, and its contents...” (Early ed. 2000: 70).

The Clement Site of the Great Bend Region in southeastern Oklahoma is associated with the Central Caddo archaeological area (Figure 22). This site was also investigated using geophysical survey and archaeological excavations (Hammerstedt et al. 2010). There are two mounds at the site. Mound A measured about 2m tall and 30m in diameter. A structure was excavated about 1m deep in Mound A by George T. Wright, but structural details are not available (Hammerstedt et al. 2010: 279). There was a tomb in Mound A as well as some pre-mound structures, but the shape, size and number of these was undetermined (Hammerstedt et al. 2010: 279-284). While little is known of the structures on the mound, there were two structures that were excavated northeast of Mound A. These structures (1 and 2) were overlapping. Structure 1 was square and measured 8m by 8m with an extended entranceway that was 2m long oriented to the southwest. Structure 2 was also square and measured 5.5m by 5.5 meters. The entranceway on Structure 2 was about 4.5 m and was oriented southwest (Hammerstedt et al. 2010: 279-284). This site was occupied periodically as early as A.D. 990 and occupations continued into a historic Choctaw period until about 1937.

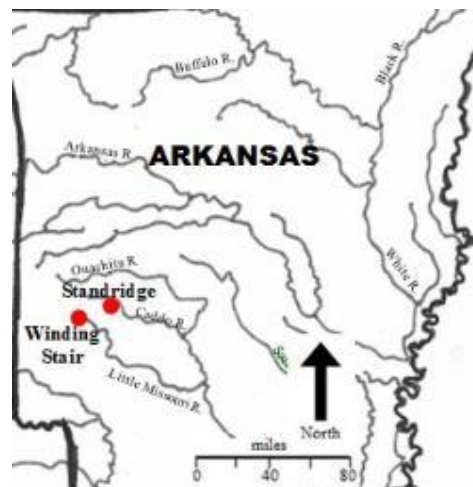
Figure 23: Location of the Standridge (3MN53) and Winding Stair (3MN496) sites.

Ann Early led an excavation of a Caddo settlement in the Southern Ouachita Mountains of Arkansas designated as the Standridge site (3MN53) (1988) (Figure 23). This excavation began in 1975 and was one of the first complete excavations done in the Ouachita Mountains region; however, not all features were completely exposed. Prior to this time there was limited understanding of specific adaptations to this region. While Harrington's work focused on the area around the Little Missouri River and Southern Ouachita Mountain regions of southwest Arkansas this was south of the Standridge site location.

The Winding Stair project in the Ouachita National Forest focused on several multi-component sites including a structure presumed to be Caddo (Early, ed. 2000: 69-92). The site is located at the confluence of the Little Missouri River and Blaylock Creek (Figure 23). A shovel test uncovered burned daub and charcoal from a structure. Because this possible structure was just off the road and accessible to forest visitors, a full excavation was undertaken. The structure was not found in association with any mounds and was in a relatively flat location. This location suggested that it was a domestic structure (Early, ed. 2000: 70). Timbers analyzed from the buildings superstructure dated to approximately A.D. 1470. So the building would have been constructed after this time. Because there was little evidence of remodeling or rotting the structure was probably used for under 20 years. The destruction of the building would have been around A.D. 1500 (Early, ed. 2000: 82).

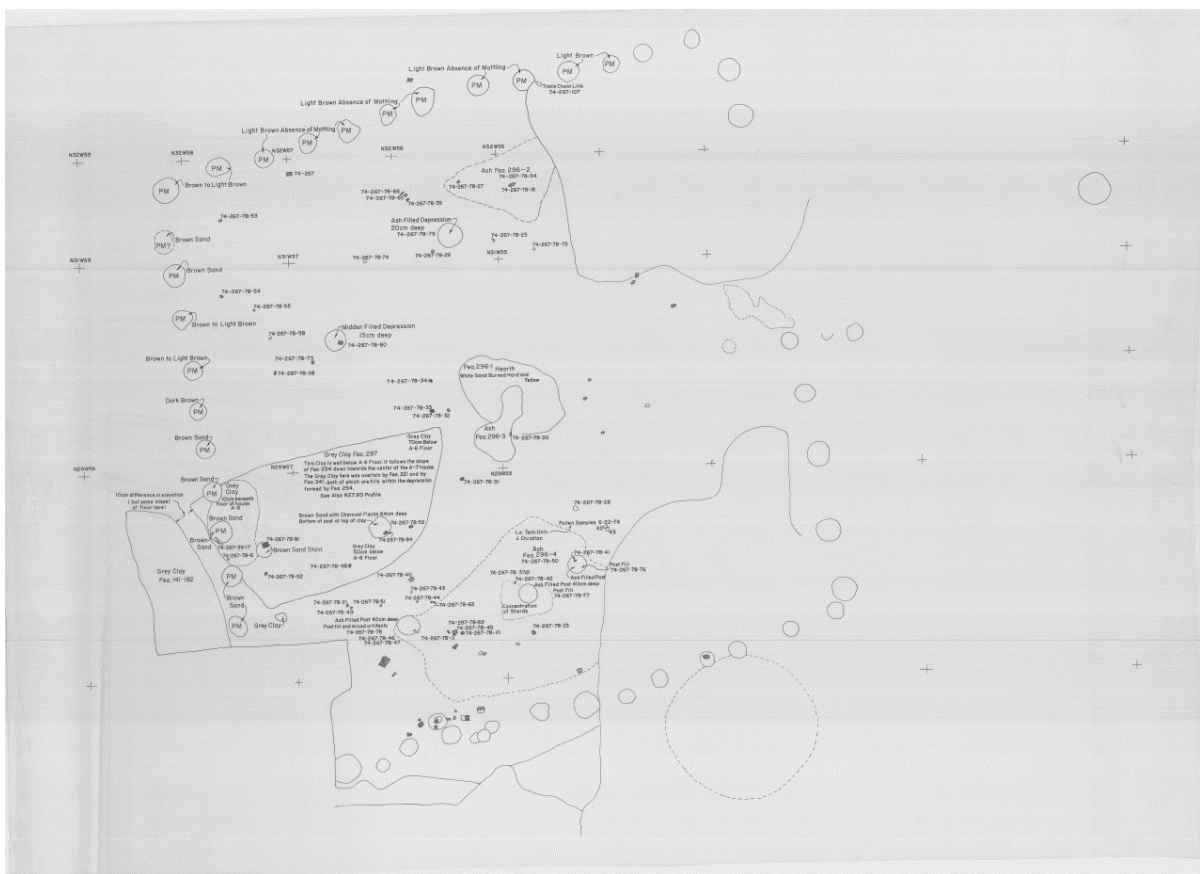
Figure 27: 3HE63, Md. A, A-6 House, Plan of A-6 Floor Fea. 296. R. Taylor and D. Kelley, unfinished artist rendering

As mentioned, no remnants among the superstructure or floor of the A-6 structure seem to belong to the roof. Some interior postmolds found within the wall post line of the building's floor may belong to roof posts that could have been removed. A possible post on the north-south line between the north wall and central hearth is about 20cm deep and was described as an ash filled depression (Figure 27). Another post between the south wall and the central hearth measured 40cm deep and was also filled with ash. About 1m between the west wall line and the hearth and 1.5m from the north wall is a possible postmold about 13cm deep described as a midden filled depression. Finally, about 1m in from the west wall and 1m east of the hearth and about 1.5m north of the south wall line is a postmold described as brown sand with charcoal flecks measuring 64cm deep (Figure 27). These four posts together show an interior postmold pattern that was also observed elsewhere at the Ferguson site (Figure 19). These may have been interior posts for roof support; however, it is not necessary that structures of this size would have had interior posts. Typically some remnants of roof material are present among structural remains. The fact that no materials among the remains were identified as belonging to the roof poses a issue that must be addressed with further analysis of the drawings and pictures of the features belonging to this structure (Figure 27 and Figure 30).

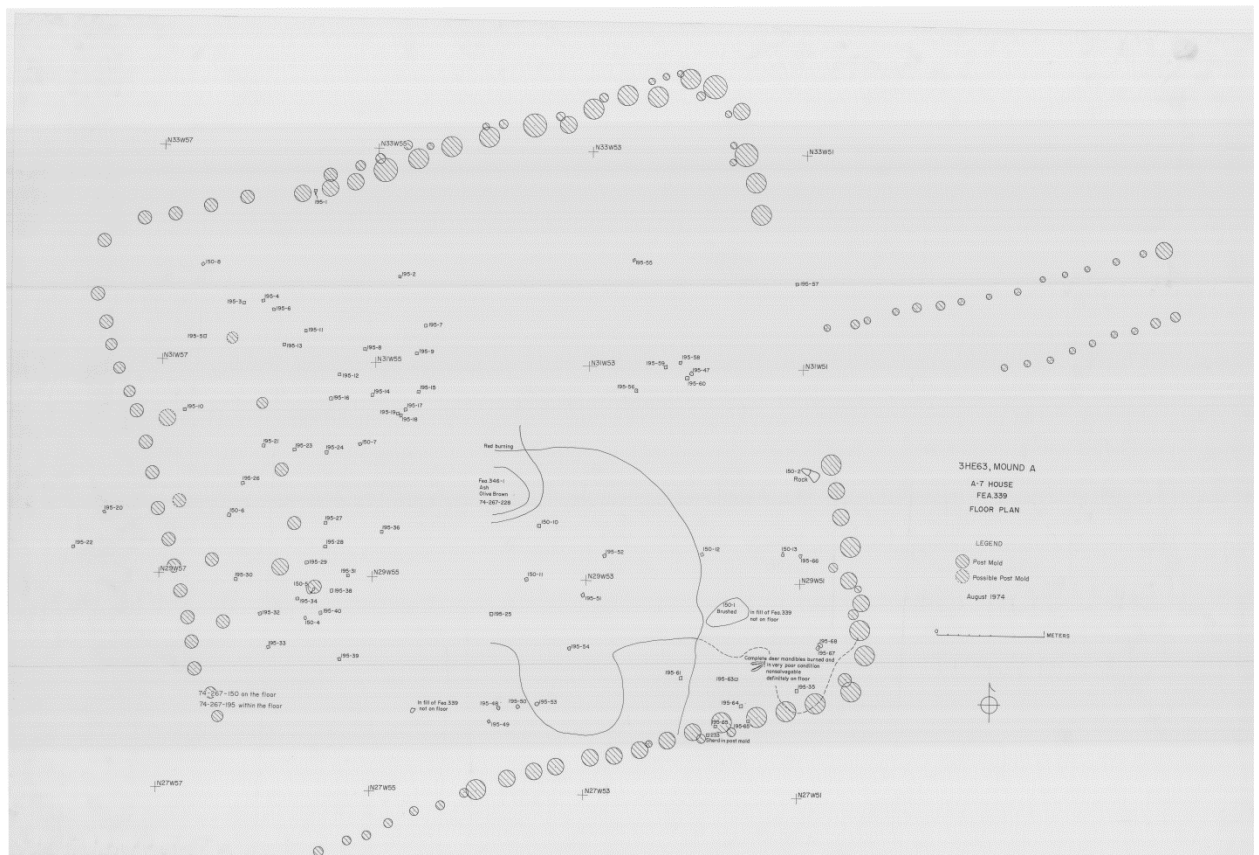
Figure 28: 3HE63, Mound A, A-7 House Fea 339, Floor Plan
