## Identifying Damage, Predicting Expansion, and Determining the Effectiveness of Sealers on Concrete Affected by Alkali-Silica Reaction and Freeze-Thaw

A thesis submitted in partial fulfillment  
of the requirements for the degree of  
Master of Science in Civil Engineering

Matthew Waidner  
University of Arkansas  
Bachelor of Science in Civil Engineering, 2015

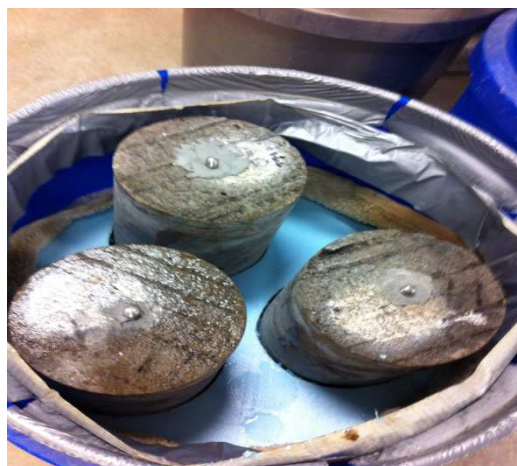
Figure 3.2. Bucket with Cores over Water

Normally, three-five gallon buckets would be used to store the nine cores in a water bath, but due to a lack of Styrofoam, three-6 in by 12 in cylinder molds were used for the 1N NaOH solution cores. The first-five gallon bucket was fitted with two wooden blocks with 1 in height at the bottom, so that 1 in. of water at the bottom could be easily measured and maintained. Above the wooden blocks, a piece of Styrofoam was cut to fit into the bucket and rest on top of the wooden blocks. Three small holes were cut just big enough in the Styrofoam for the gage studs to fit in. The cores would rest on the Styrofoam, while the gage studs would not carry any of the weight of the cores being in the holes. Four inches from the top of the bucket another Styrofoam piece was place with three holes cut into it symmetrically about the center. These holes were made just bigger than four inches to accommodate the cores. The sides of the bucket were lined with a towel. The towel was taped to the top of the bucket, while the bottom of the towel sat above the bottom piece of Styrofoam. Figure 3.2 shows the cores in the first bucket. A lid fitting over the bucket and towel was used to create a water tight seal.

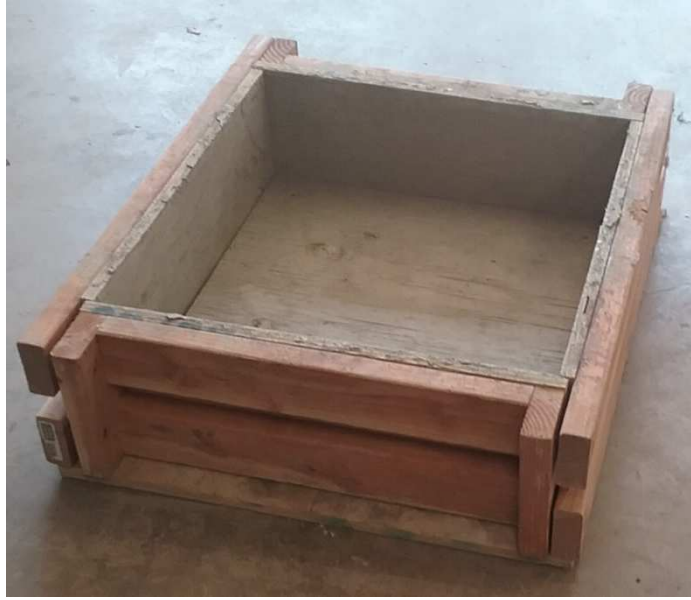
Figure 3.5. Formwork

The concrete was mixed and placed into two forms that were two feet by two feet by eight inches deep as shown in Figure 3.5. The bottom of the forms was made of plywood with four holes, so that gage studs could be placed into the concrete. As the concrete was placed into the forms, it was rodded and consolidated. After the concrete was placed, the surface was finished with a trowel.
