Habitat assessment and ecological restoration design for an unnamed tributary of Stone Dam Creek, Conway, Arkansas

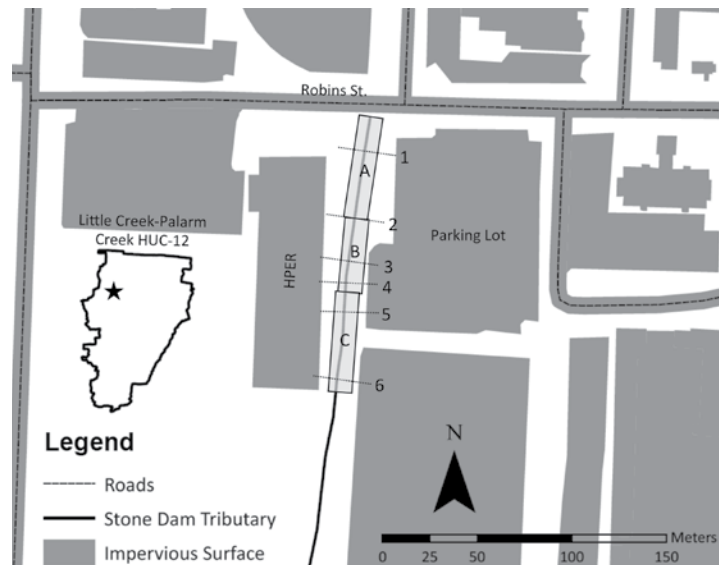
Fig. 2. Map of the study area within the Little Creek-Palarm Creek HUC-12 watershed. Study sections where Rapid Bioassessment Protocol assessment was performed are labeled A, B, and C. Surveyed cross sections are labeled 1-6.

which is currently undergoing construction. The area under study begins where the tributary exits the culvert south of Robins Street and ends at the far end of the HPER building, a total length of 138 m. The area was further broken up into three sections, with breaks between sections 1 and 2 at the dam and between sections 2 and 3 at the point of change in canopy cover (Fig. 2).
