A step in the right direction: streambank restoration efforts at the Botanical Garden of the Ozarks

Abstract

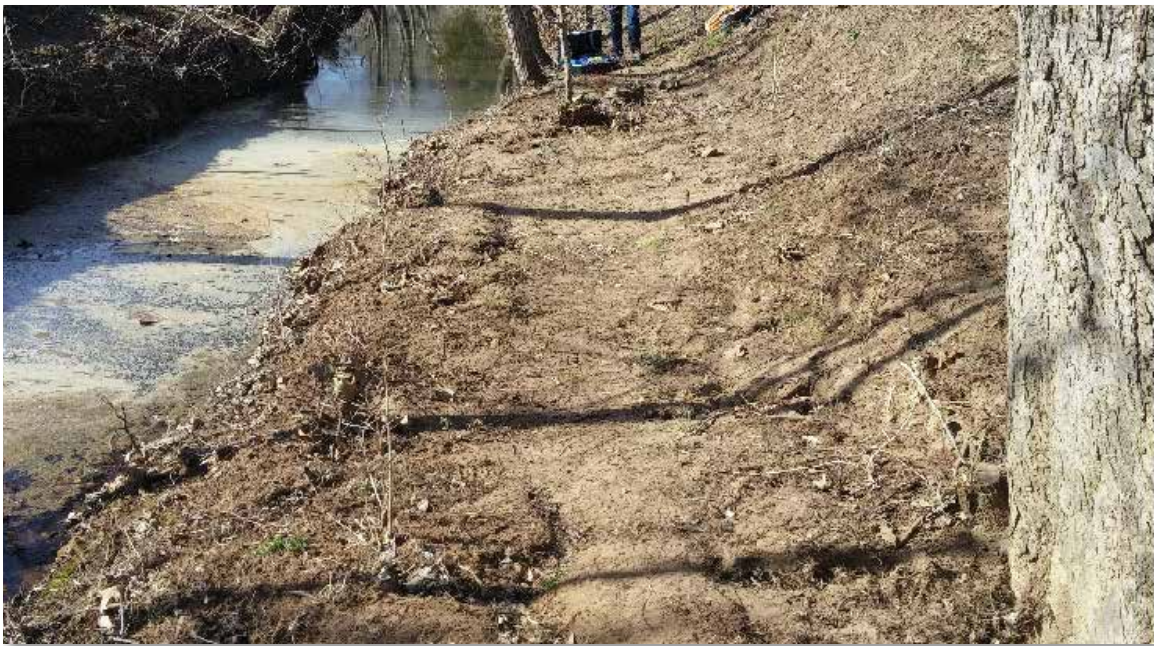
Fig. 2. Hilton Creek streambank at the Botanical Gardens of the Ozarks, Fayetteville, Arkansas shown pre-restoration, 7 Feb. 2016.

The Hilton Creek streambank pre-restoration site was devoid of vegetation with exposed soil, susceptible to erosion (Fig. 2). Post-restoration holds a diversity of native vegetation providing significant ground cover to minimize erosion (Fig. 3). Soil test results from one discreet sample from the geographical center of Zone C indicated the soil contained approximately 81.82 and 84.07 (kg/ha) of nitrate and phosphorus respectively, and had a pH of 6.9. Soil test values confirmed the site was suitable for planting desired native trees, shrubs, herbaceous perennials, ferns, and grasses arranged in the design (Fig. 1).

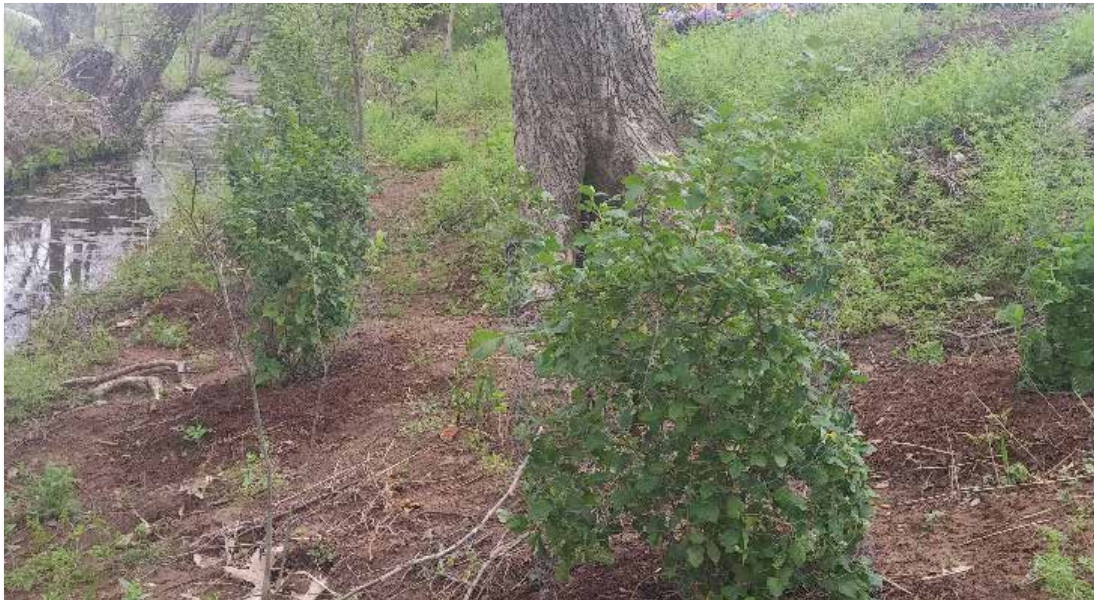
Fig. 3. Hilton Creek streambank at the Botanical Gardens of the Ozarks, Fayetteville, Arkansas shown 5 April 2016 post-restoration, after the 3 April 2016 planting day.
